## **ALTERNATIVE METHODS OF FLOOD MITIGATING EXISTING STRUCTURES**

**Paul Gugenheim**

*President and CEO,  
Delta Structural Technology Inc.,*

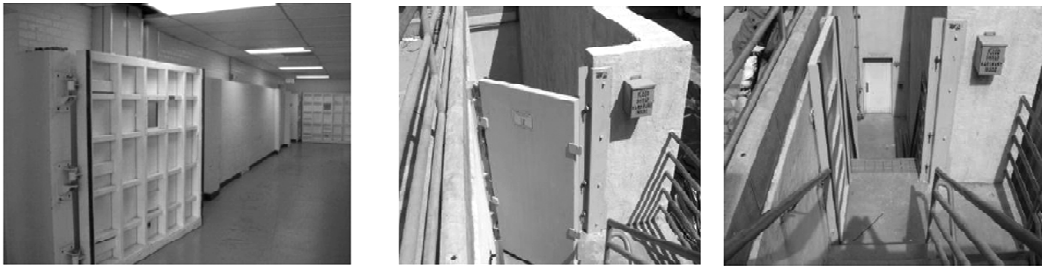
Figure 1: Various Swing Type Flood Doors

All of the buildings required the installation of flood doors and strengthening of the walls for the mounting of the doors and resisting the forces of the flood waters. Several types of doors were installed. The most common was the swing door with either air filled seals or foam

core seals. These doors require activation by the maintenance staff prior to the event. The other door was a passive door that the flood waters lift without any activation from the staff.

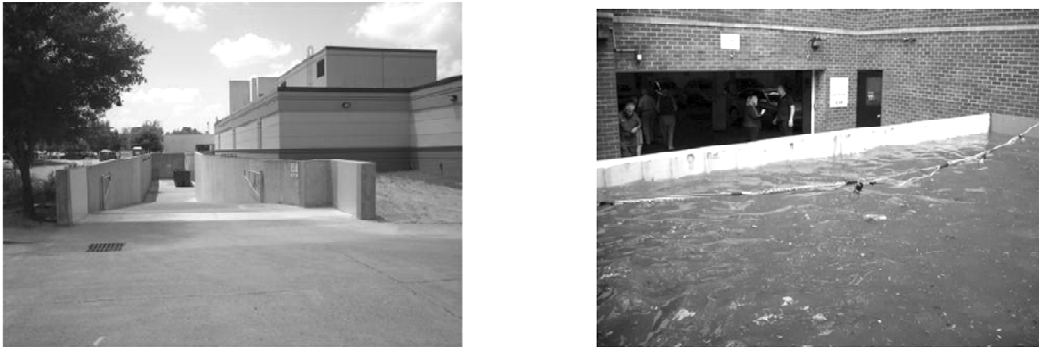
**Figure 2: Passive Flood Door Before and After Activation**

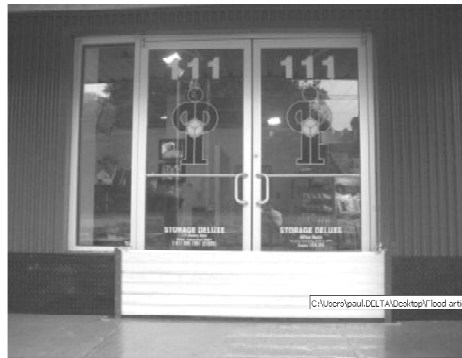
**Figure 3: Simple Drop in Slat Door for Low Levels of Water**

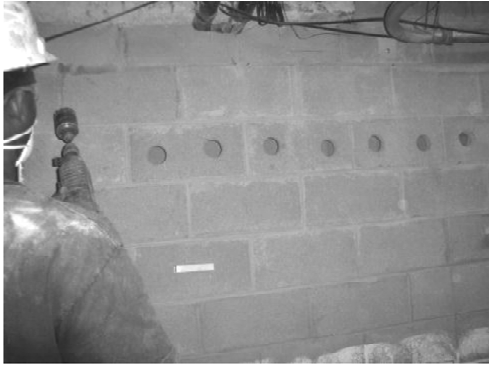
**Figure 4**

**Drilling and Pouring Concrete Grout  
for Wall Strengthening**

The FEMA-provided flood hazard data for this site indicated that the Base Flood Elevation mapped for this site was elevation was approximately 5 feet above existing grade. Using this flood depth, and also considering one foot of freeboard, the wall was analyzed for a flood condition that placed 6 feet of water above grade and against the structure. With this information, the unreinforced cmu external walls would not resist the flood water pressure and needed to be reinforced. Many of the walls required drilling holes in each vertical line of cmu cells, vacuuming out the existing vermiculite insulation, and filling the walls to a height of six feet with grout. Prior to the infill, eight foot long reinforcing steel bars were inserted on 24" centers with two feet epoxied into the grade beams.

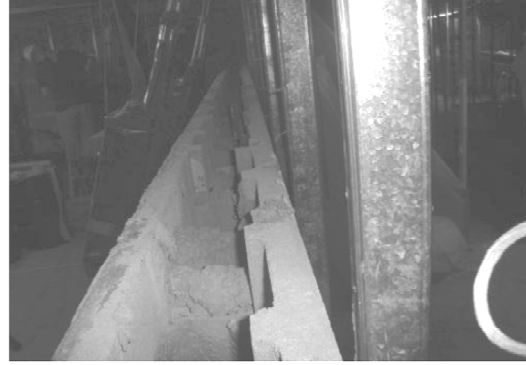
**New 6 ft. tall CMU Walls with Grout Infill**

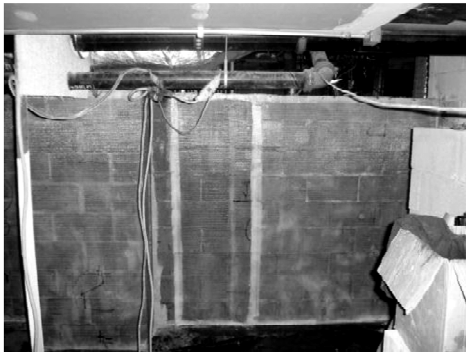
**Figure 5**

**FRP Wrapped Wall Under Construction**

After the infilling was complete, the walls were covered with e-glass frp to a height of six feet and eighteen inches along the floor to insure a good seal at the joint of the slab and wall. The frp was then painted with a polyurethane paint for UV protection and finish.

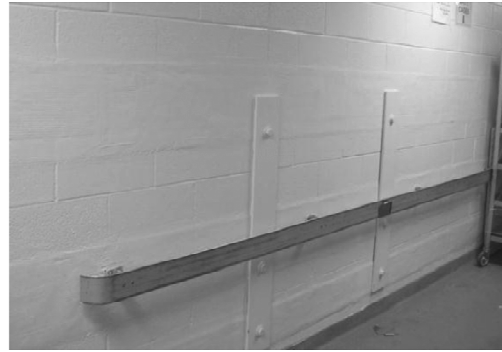
**Completed Wall Strengthened  
and Waterproofed**

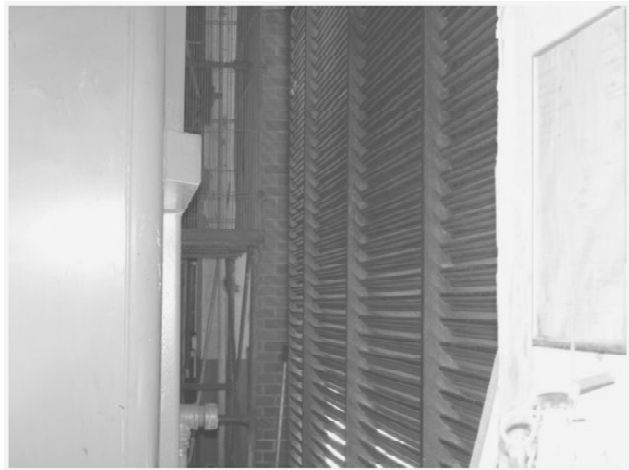
The boilers and the power units presented challenging design problems. First, the power units required specific air inflow to cool the radiators and in turn cool the power units. The intakes were large louvers that were below the six foot flood level.

**Figure 6: Louvers That Extended Below the Flood Level**

It was decided in the final design was to change out the cooling jackets for water coolers, raise the louvers above the FEMA-provided flood hazard data for this site indicated that the Base Flood Elevation mapped for this site was elevation of 5 feet above existing grade plus the one foot of freeboard for a total of six foot and turn them horizontal to get the correct amount of air flow needed. With the boilers, the area needed to remain open for servicing and the boilers could not be moved. The flood door company designed a customized vertical lift door that was not a roll up, but rather on an external vertical track with the door stored vertically

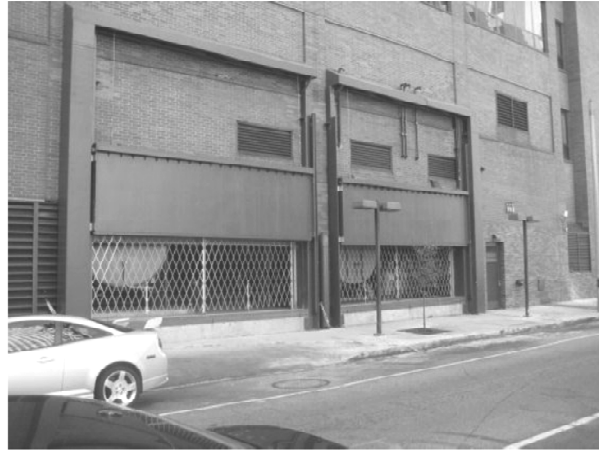
**Figure 7: Vertical Guillotine Doors Prior to Flood Test**

above the opening and closed only for inclement weather. It should be noted that no flood door should be used daily in place of a walk through door as the seals will wear out and lose the watertight fit.

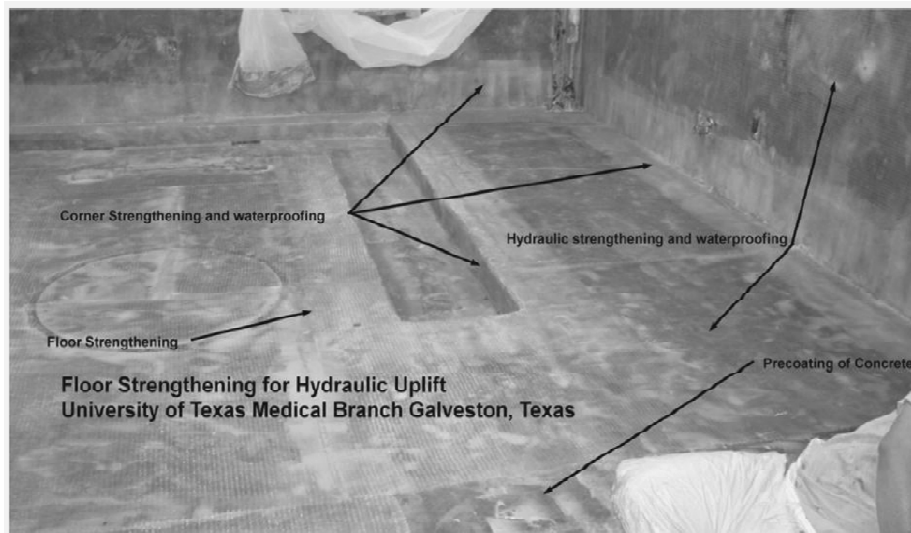
One question that continues to arise is the issue of ground water from flood surge below the slab. This occurred in Galveston at a hospital and the frp e-glass was run across the floor and sufficiently strengthened the structure to stop water penetration.

**Figure 8: Floor Strengthening for Uplift From Tides or Ground Water**

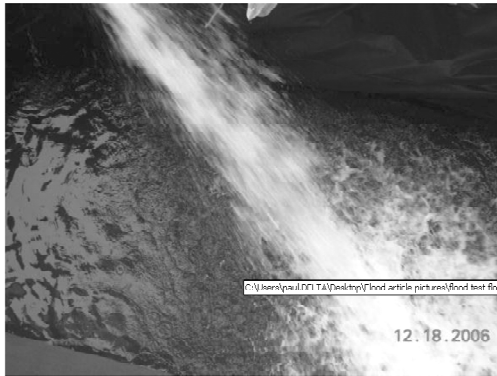
**Figure 9**

After completion of the project, water was pumped into the sumps and the flow capability substantiated. Following the sump test, the hospital built a sandbag dam around the central plant and flooded it to full design height of five feet to check for seepage and leaks. The system worked as designed.

**Actual Flood Test at HCA Tulane Hospital**

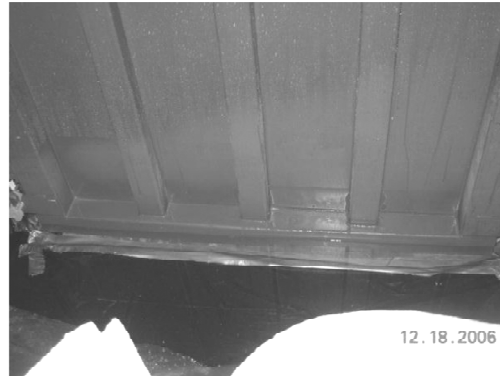
**Flood Door with Six Ft of Water and No Leaks at the Door or Walls**
