Structural Repair and Rehabilitation of Multi-Storeyed (G+11) Residential Buildings: A Case of Surat, Gujarat

In Ahmedabad Asset of ONGC, three no. multi-storeyed (G+8) buildings viz. Heera (C3), Panna (B5) and Ratna (B6) each having 68 quarters with half G.F as parking were constructed in year 1989-1990. These buildings were already sick due to severe reinforcement corrosion as evident from so many spalls, delaminations on column corners located at different heights, beam/ fin soffits, slab soffits, leached plaster on parapets corroded and leaking drainage pipes, water supply lines and stagnated water on terraces due to improper gradient etc. These were further damaged by the Bhuj earthquake on 26th Jan, 2001 in the form of separation cracks at beam-column junctions, RCC-masonry wall interfaces (Fig 6), cracks in masonry in-fills(Fig 5); even complete crumbling at some places, heavy de-bonding and dismantling of plaster at both exterior and interior surfaces etc. Due to fast deterioration, it was decided to rehabilitate these buildings at the earliest.

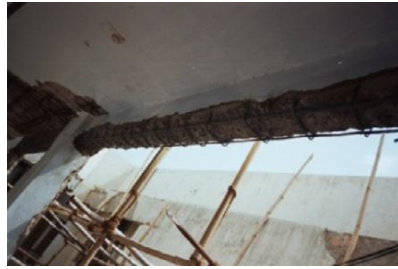
Fig.1

Visual inspection of the buildings indicated heavy rebar corrosion as a result of carbonation due to environmental attacks. At certain locations of beams, columns, fins and slabs concrete cover had got spalled (Fig 3) and some shear stirrups were totally eaten up by corrosion (Fig1). Beam - column junctions were badly cracked (Fig 2). Some masonry walls at GF level were totally cracked due to earthquake. A number of columns had continuous vertical cracks along the line of concrete cover thickness (Fig 4). The visual inspection necessitated the need for detailed evaluation for design of the rehabilitation design.

De-lamination of beam concrete cover due to rebar corrosion.

At the location, where concrete cover had already spalled eg. Columns corners, soffit of beams, slabs and fins, loose concrete was removed 25cm more than the length of spall. For other areas which were not spalled, hammer sounding method was used to locate delaminated concrete and marked with paint. Surface repair boundary with 5mm groove using concrete saw cutter with minimum

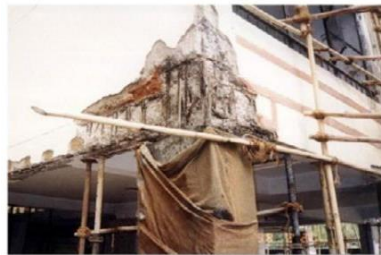
Fig.2-

Severe corrosion and spalling of beam – column junction due to poor workmanship and in-adequate cover at GF level.

Cracks in RCC members especially beam-column joints were grouted with epoxy grout of the following composition specially formulated to meet the required specifications (100 gms GY257+21 gm Aradur 21 + 4 gms Aradur 2958) from Araldite and the grout was of the following properties: Viscosity at 25°C max: 2 N/ sq m, Minimum Gel time: 30 minutes,14 days bond strength at

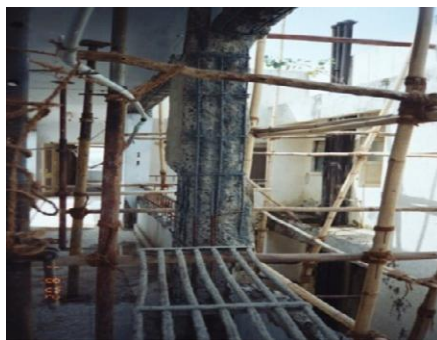
Fig.7

Column rebars with anti -corrosive coating

Anti corrosive zinc primer was coated on freshly cleaned and dry reinforcing steel on complete periphery as per manufacturer's specifications and allowed the primer to dry for 4 hrs (Fig 7). The second coat of zinc primer after 4hrs of the application of first coat was also applied. Care was taken to cover all the steel without leaving even the smallest part of steel uncovered. The coverage rate of zinc based anti –corrosion coating on the steel bars came out to be about 2.4 sq. m per litre of the chemical which was much lesser than the claims in the technical brochures. The bars having more than 20% of the reinforcement steel bar cross sectional area corroded were replaced with the additional reinforcement by welding with existing bars or by drilling holes in to concrete and inserting the steel bars with epoxy mortar. There was severe corrosion of shear stirrups in beams resulting in decrease in diameter by more than 25%, so these were also replaced with new U- shape stirrups.

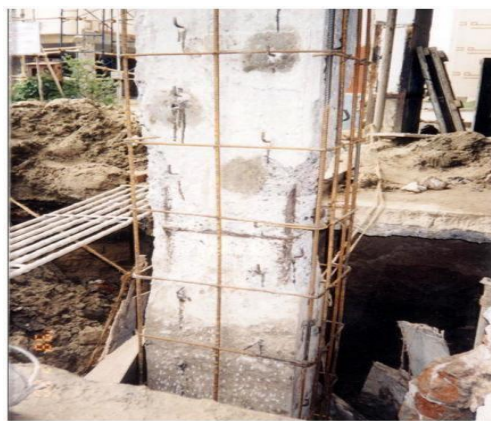
Fig.9

Some of the columns were badly cracked throughout their height in the parking area and some had deep spalls at corners due to rebar corrosion. Some columns were badly damaged at floor level. These columns were jacketed with new rebars and jacketing concrete by 75mm thickness all-round to increase its strength and stiffness and to protect its reinforcement from further corrosion (Fig 9). The ready to use jacketing concrete in which coarse aggregate of 6-10 mm down size was to be added as per recommendation of the manufacturer was used. The Jacketing concrete was of following properties with water powder ratio of 0.21 at 30°C and with 100% aggregates: Compressive strength- 30N/sqmm mini at 30days, Flexural strength -3.0N/sqmm mini at 30days , Young's Modulus- 22 KN/sqmm.

Jacketing of columns from the footing level.

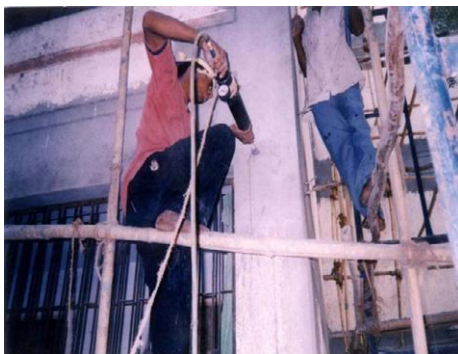
Fig.10

Epoxy injection in beam-column junctions
