The Impact of Nanotechnology on Exterior and Interior Finishing Materials in Hospitals

Mohammed Th. Mahmoud^{1,2}, Henar A. Ahmed³, Mohamed S. Kamal al-Din⁴

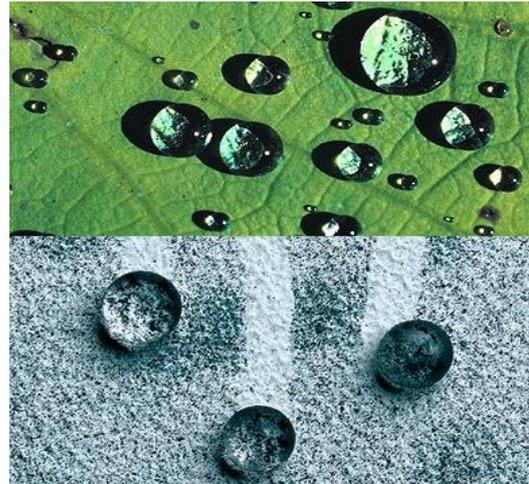
Figure (1) illustrates the idea of the self-cleaning technique of the lotus effect, which shows that the surface contains nanoscale models that carry water droplets, which in turn take the dust with them and fall.⁵

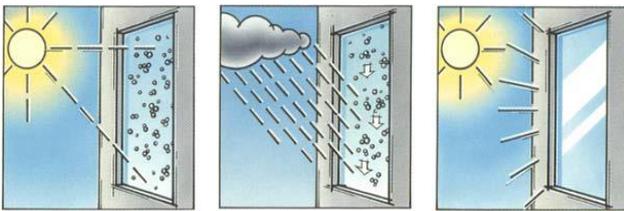
Figure (3) shows that when the building's exterior glass is exposed to sunlight, air and rainwater, the self-cleaning technology "Photocatalysis" works very efficiently to reduce sunlight ingress, resist air, and expel rainwater.⁹

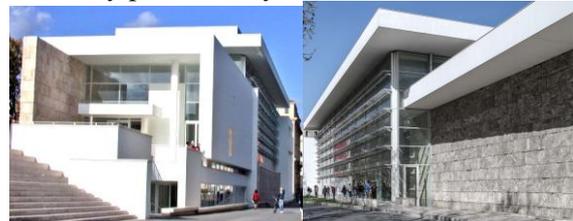
Figure (4) shows the bright white paint used to upgrade the building's exterior facades, developed with a self-cleaning technique that works to preserve the purity and clarity of color in the heavily polluted city of Rome.¹⁰

building contains a part completely covered with glass, and it is protected against the influences of the surrounding environment, the building is coated with a layer of paint developed with a self-cleaning technique to maintain the white color It is shown in Figure (4), the building's original color, the Meier's character in Rome, which of course did not last long in a heavily polluted city like Rome.¹⁰

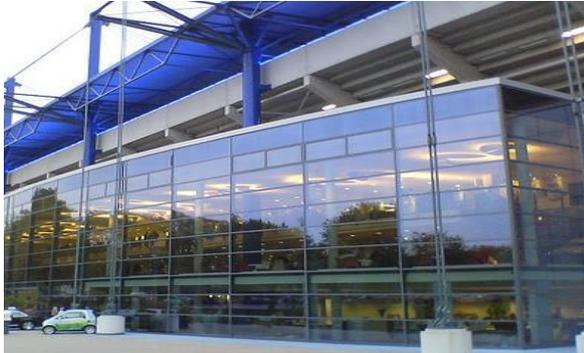
Figure (5) shows the glass facade of the building from the outside and the inside, which works with self-cleaning nanotechnology, as well as noise isolation and protection from sunlight.¹¹

square meters and a width of 120 square meters, and a "photocatalytic" self-cleaning technique was used in the glass, which also works on protection from sunlight and also has noise isolation⁵, as shown in figure (5).

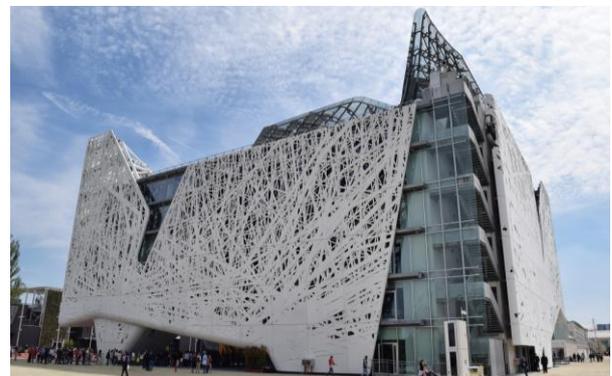
Figure (7) shows the building of Expo Milano 2015 - The Italy Pavilion, which consisted of white, irregularly shaped façades, punctuated with openings, and the façades were made of a mixture of cement and titanium dioxide.¹³

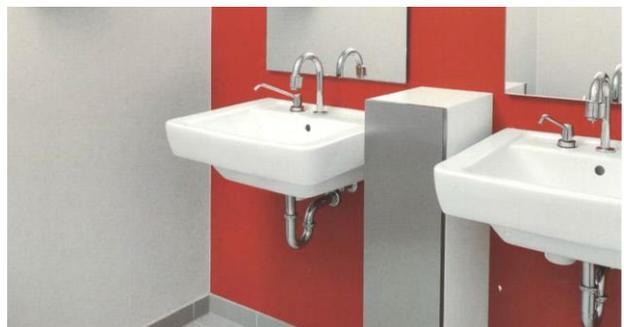
Figure (10) shows the distinctiveness of these surfaces with their vapor permeability and water repellency properties. They are easy-to-clean surfaces, as they can only be cleaned with a small amount of water.⁵

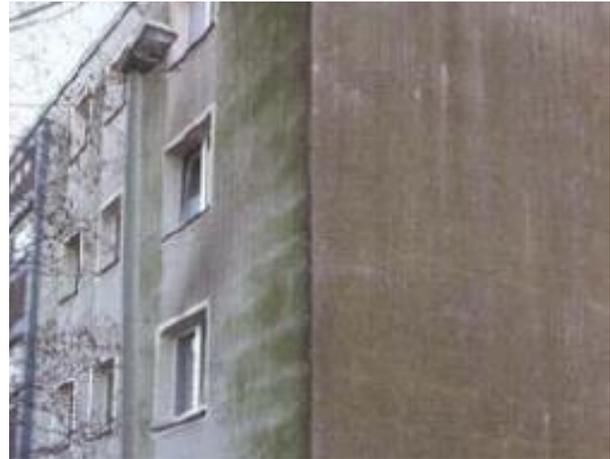
Figure (12) shows the facade of the building, which shows the accumulation of bacteria.¹⁴

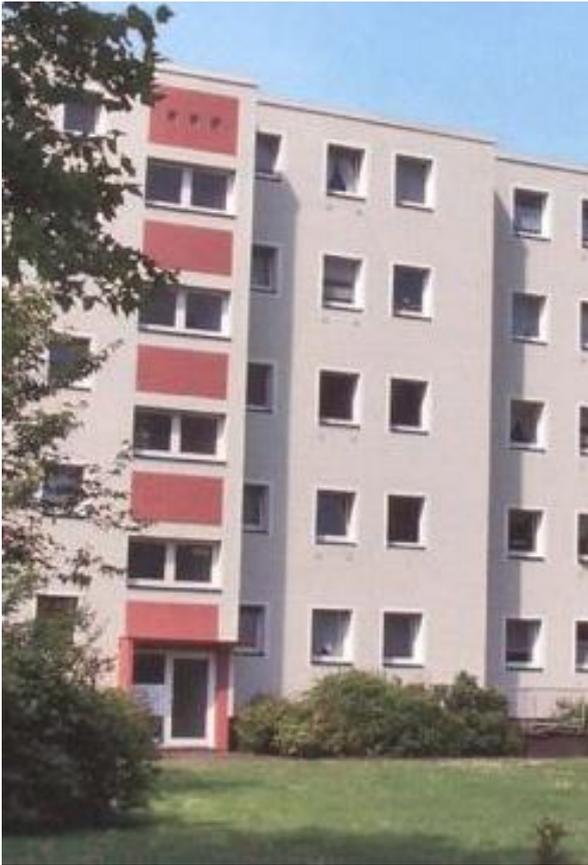
Figure (13) shows the building after being treated with an anti-bacterial nano coating.¹⁴

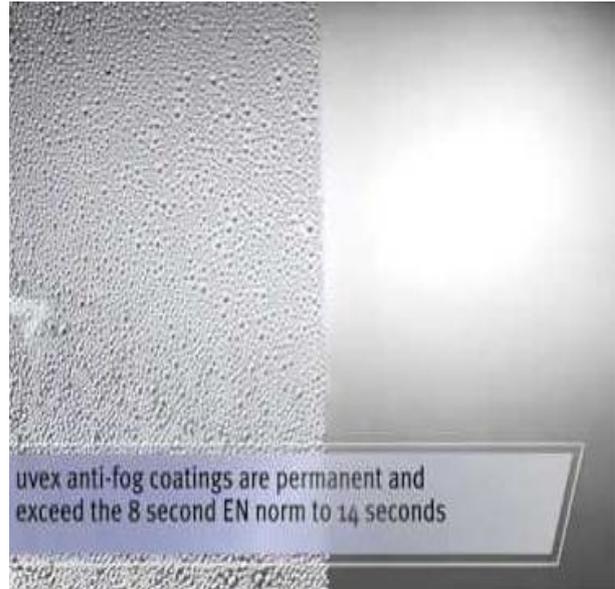
Figure (14) shows a pane of glass, half of which is left side of normal glass and the right half of anti-fog glass.⁵

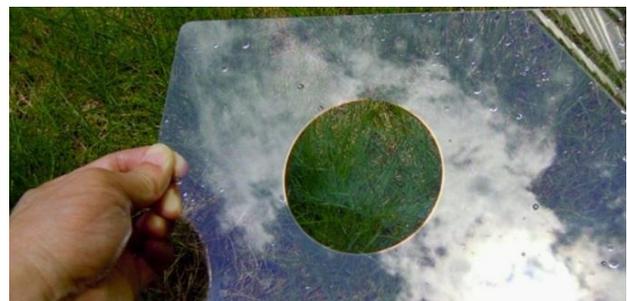
Figure (15) shows a glass plate in which the circular area has been coated with an anti-reflective nano-coating, while the rest of the plate has not been coated.¹⁷

The anti-reflection coating shown in Figure (15), is used in buildings, especially in the interior spaces of exhibitions and museums, to display exhibits or antiques in a protective glass box. The anti-reflective prevents such reflections on the glass to make the box as if it does not exist, and silica dioxide nanospheres are used in the anti-reflection nano-coating with a size of 30-50 nm, and the thickness of the coating on the surface of the glass is 150 nm and reduces light reflection from 8% to 1%, and anti-reflective coating is widely used as it is used in **television screens**, mobile phone screens and computer screens, and was also used in solar collectors to prevent the reflection of solar rays.¹⁶

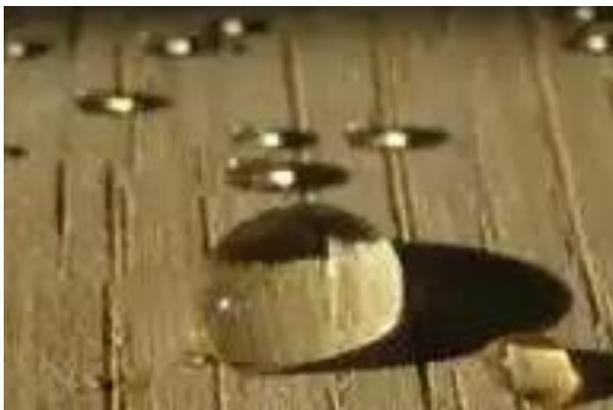
Figure (16) shows the surface of wood treated with a layer of water-repellent nano coating.¹⁹

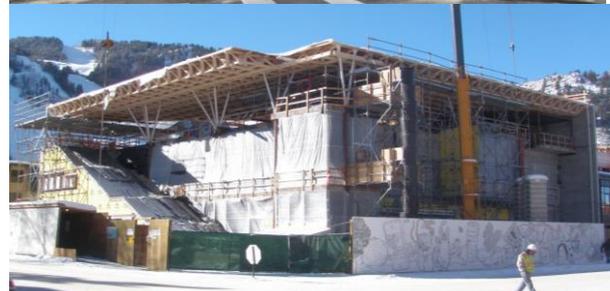
Figure (17) shows the Aspen Museum of Art building and its affiliation with the surrounding nature. It also shows the use of wood treated with nanotechnology in making the ceiling of the last floor of the building.²¹

The Aspen Museum of Art is the first permanent museum of architecture in America, and the architect created a sequence specific to the site that takes into account the views of the surrounding mountains and the function of the building as a museum of art, as shown in Figure (17), and to open to the outside where visitors can appreciate The museum's beauty is inside, and the project's architect aims to pressure companies to design more nano-coated wooden structures, which is characterized by its strength, hardness and endurance like concrete, environmentally friendly, lightweight, low cost, flexible and acceptable Shaping, easy to clean, highly resistant to weather, temperature and UV rays. The building's exterior was covered with a woven mesh of braided laminate made of Prodema, as shown in Figure (18), a mixture of resin and paper; It exists as a middle layer between two layers of wood lacquer, and the two sides of the corner are clad in this way, which is somewhat like the "Mashrabiya".

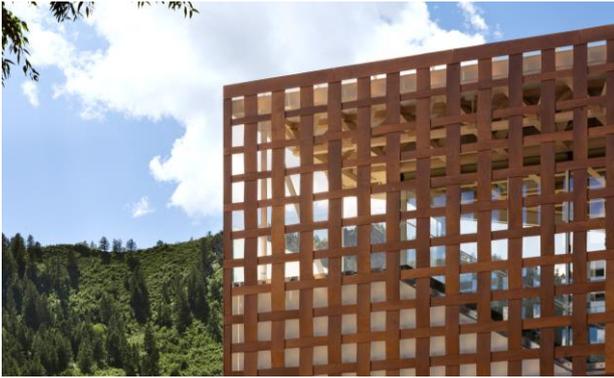
Figure (18) shows the covering of the building's exterior with a mesh woven from braided wooden sheets.²²

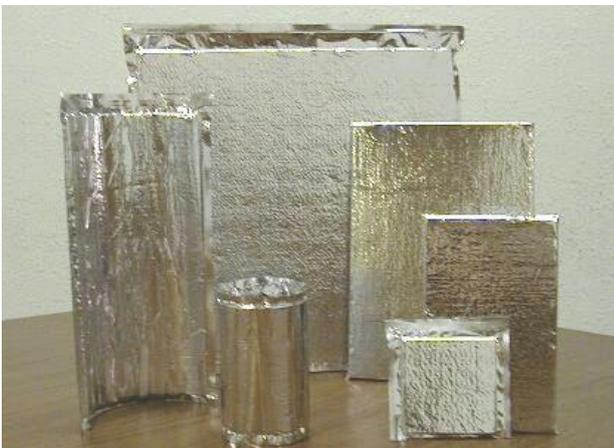
Figure (19) shows vacuum insulation panels (VIPs) of different shapes and sizes.²⁵

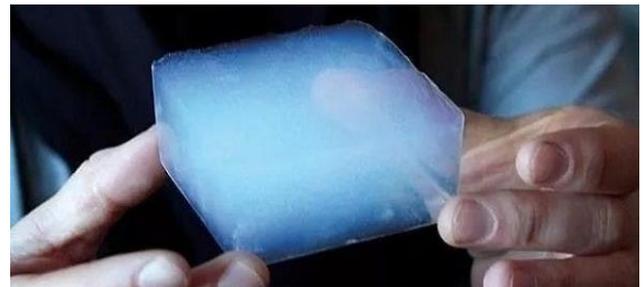
Figure (20) shows the transparent material of the aerogels.²⁷

It is a substance with wondrous properties known as “Frozen Smoke or Blue Smoke”, and it is prepared from sodium silicate and consists of 5% solid and 95% air. Its density is not more than 3 mg/cm³. It has a high ability to thermal and sound insulation and to provide natural lighting and is used to fill various types of cavities between glass panels, and therefore it is suitable for use in the outer shell of the building, as it helps reduce heating and cooling costs because it is transparent and helps light transmit well. The lightest solid material made by man.²⁶

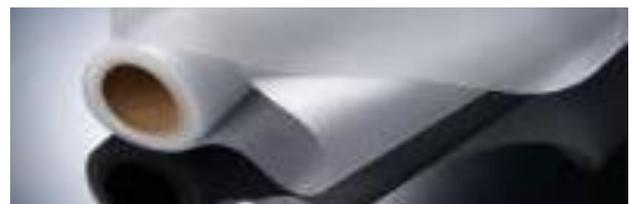
Figure (21) Describes the thin films used in thermal insulation of glass.²⁸

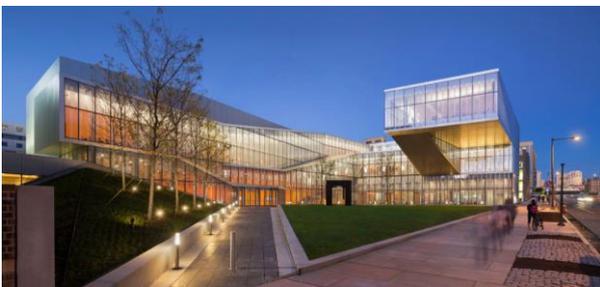
Figure (23) shows the building's glass facades that are self-cleaning, anti-bacterial, anti-scratch, and have high thermal and acoustic insulation (nanogel).³⁰

In this project, self-cleaning and anti-bacterial nano glass facades were used, and nanogel sheets with high thermal performance were used in the building facades, which thickness reaches 7-12 mm, and they work on thermal and sound insulation at a very high rate, where the thermal conductivity coefficient reaches "U-Value" is less than 5.0 W/m² Kelvin, and these facades are characterized by saving 20% of daylight without glare, and the transmittance of natural light reaches 88%, and nanomaterials have also been used in the internal and external walls with anti-scratch. All this leads to energy savings and lower operating costs for the building.³¹

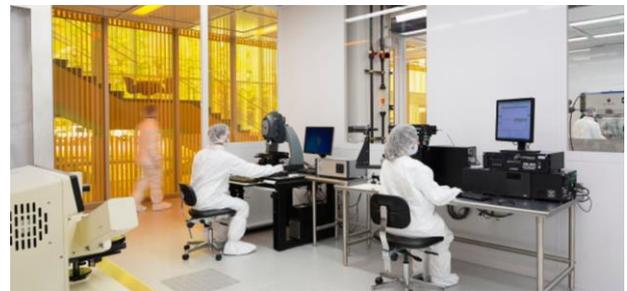
Figure (24) shows some of the interior spaces of the building, whose walls were used nano-anti-scratch technology.³⁰

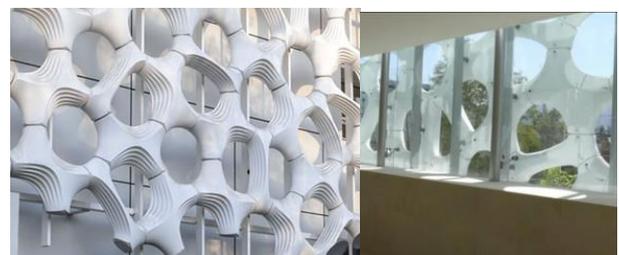
Figure (26) shows the facades of the hospital in which brick panels are used with air purification technology and the reduction of pollutants, which also serves as a canopy for the facade of the hospital.³⁴

The building panels produced by Elegant Embellishments in Berlin-Germany are completely covered with a dense layer of titanium dioxide as a pigment that acts as a catalyst for chemical reactions when exposed to sunlight. When sunlight touches special slabs of bricks, it interferes with the chemical process, the reaction that turns mononitrate into less harmful substances such as calcium nitrate and water as well as carbon dioxide and titanium dioxide does not change and does not weaken its effectiveness over time but remains effective forever.

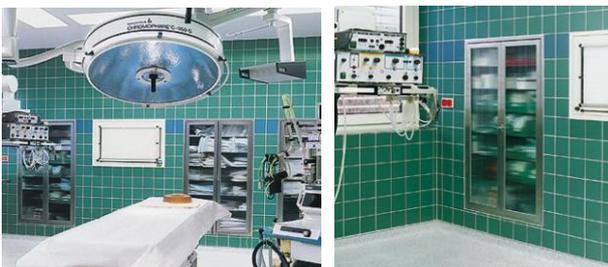
Figure (27) shows the use of nanoceramic anti-bacterial and anti-fungal in the operating room in the hospital.³⁵

Materials Used	
Design Element	Product
The Room's Floor	antibacterial floor covering
Bathroom Floor	Subway with Ceramic plus treatment (easy-to-clean)
Room Walls	air-purifying wall paint
Bathroom Walls	Jasba Centino with ETC treatment

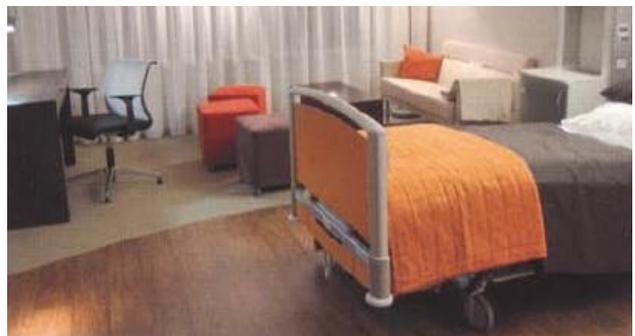
Figure (28) shows the room's interior furnishings, which are treated with anti-bacterial technology and purify the indoor air from any pollutants.⁵

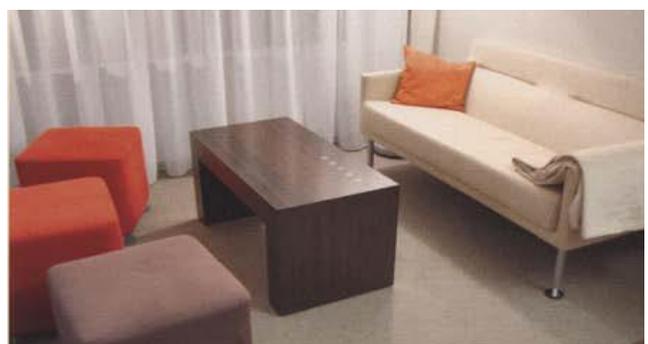
Figure (29) shows the use of anti-bacterial floors and wood to keep the room clean from bacteria and microbes.⁵

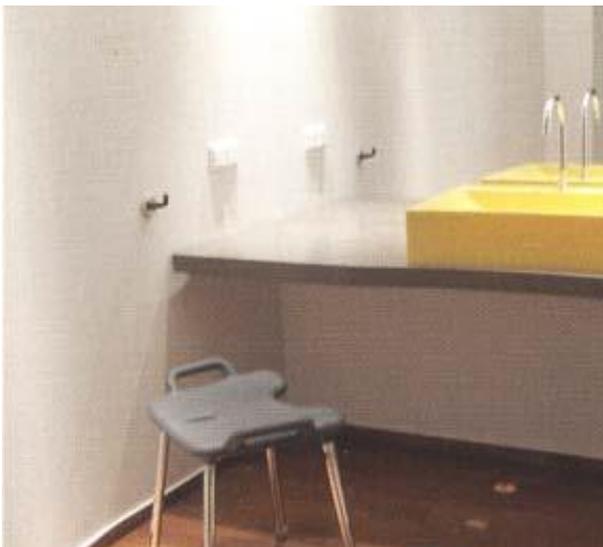
Figure (30) the use of easy-to-clean, anti-scratch and anti-steam surfaces in the bathrooms of patient rooms in order to save maintenance costs and not to condense water vapor on the mirrors.⁵

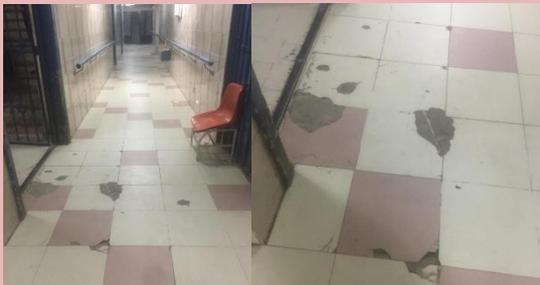
<p><u>The main corridor</u> Flooring: ceramic tiles The image shows the appearance of fractures in some ceramic tiles, some of which are not completely, and it shows the hospital's neglect in the necessary treatment and maintenance for these parts.</p>

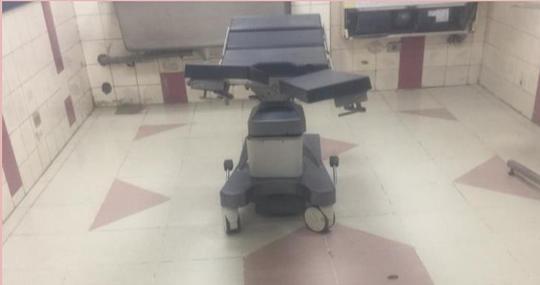
<p><u>Minimal intervention room</u> Flooring: ceramic tiles The image shows the appearance of fractures in some ceramic tiles, some of which are not completely, and it shows the hospital's neglect in the necessary treatment and maintenance for these parts.</p>

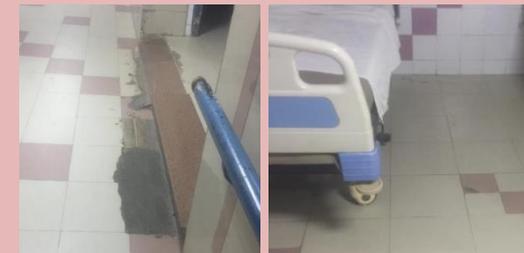
<p><u>Detection and diagnosis room</u> Flooring: ceramic tiles The image shows the appearance of deterioration and fractures in some ceramic tiles, which were treated with cement mortar instead of being replaced with usable tiles.</p>

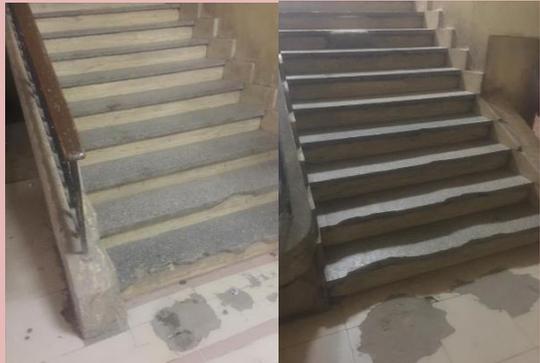
<p><u>main staircase</u> Flooring: Granite and marble tiles The image shows the crushing of the granite slabs used in the staircase, and their edges are broken, and they are not replaced or treated by maintenance officials, with the presence of cracks in the floor with ceramic tiles that have been treated with cement materials, and this treatment is wrong and incorrect.</p>

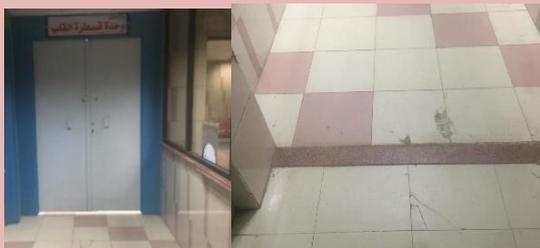
<p><u>Cardiac catheterization unit</u> Flooring: ceramic tiles The image shows the presence of cracks in some ceramic tiles, and the lack of interest in treating the floor and replacing the broken tiles with others.</p>

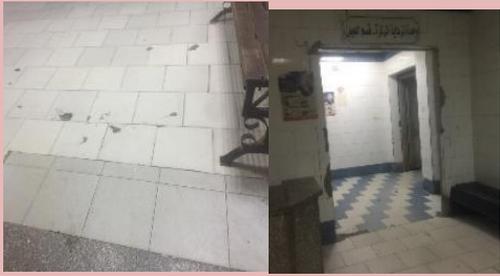
<p style="text-align: center;"><u>Reception and waiting area</u></p> <p>Flooring: ceramic tiles</p> <p>The figure shows the erosion and crushing of most ceramic tiles. The figure also shows the treatment of these defects by filling the broken spaces with cement mortar, and this is a very poor treatment.</p>

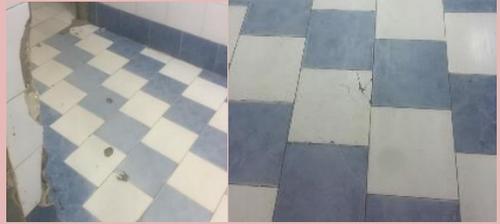
<p style="text-align: center;"><u>The main corridor</u></p> <p>Flooring: ceramic tiles</p> <p>The figure shows the presence of some cracks and cracks in some ceramic tiles that were not treated by replacing them with others.</p>

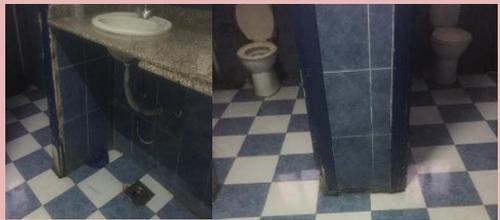
<p style="text-align: center;"><u>Bathrooms</u></p> <p>Flooring: ceramic tiles</p> <p>The image shows the neglect of the hygiene factor, where water and dirt accumulate, which results in the formation of bacteria and microbes.</p>
	Intensive Care Unit - Cardiac Department

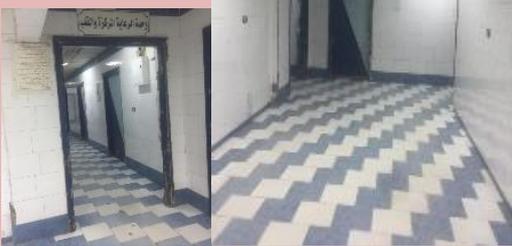
<p style="text-align: center;"><u>Department entrance and waiting area</u></p> <p>Flooring: ceramic tiles</p> <p>The figure shows the presence of some cracks and cracks in some ceramic tiles that were not treated by replacing them with others.</p>

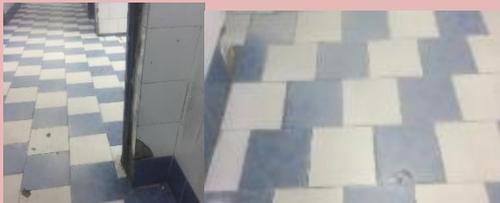
<p style="text-align: center;"><u>The main corridor</u></p> <p>Flooring: ceramic tiles</p> <p>The figure shows the presence of some fractures in some ceramic tiles that were not treated by replacing them with others.</p>
	Second Floor	Vascular Surgery Department

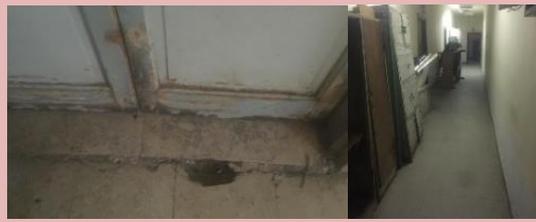
Doctors' residence

Flooring: mosaic tiles
The floor appears poorly due to the use of mosaic as a finishing material, and moisture appears in it, which spreads bacteria.

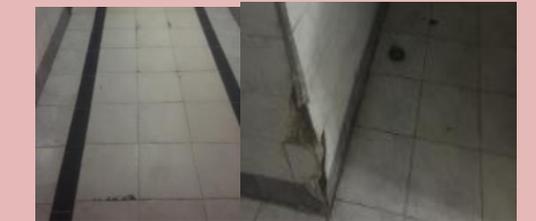
The main corridor

Flooring: ceramic tiles
The figure shows the presence of some fractures in some ceramic tiles that were not treated by replacing them with others.

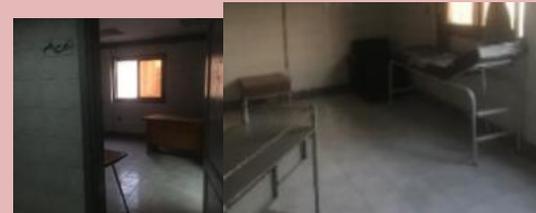
Head of Department

Flooring: ceramic tiles
The figure shows the ceramic floors shown here in this space well.

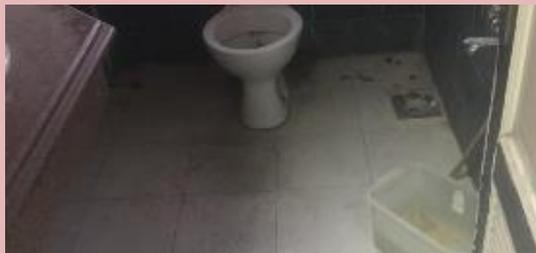
The head of the department's toilet

Flooring: ceramic tiles
The figure shows that the ceramic floor appears poorly in terms of hygiene, as the floor appears dirty, which helps the formation of bacteria and microbes.

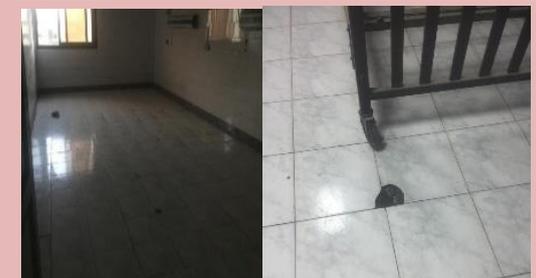
Some patient care rooms

Flooring: ceramic tiles
The figure shows the presence of some fractures in some ceramic tiles that have not been treated by replacing them with others, as well as the lack of attention to general cleanliness.

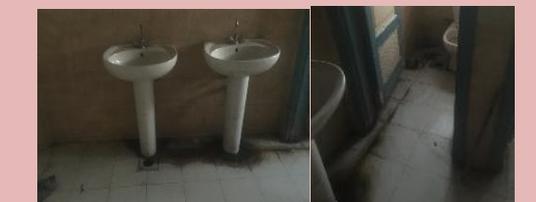
Bathrooms

Flooring: ceramic tiles
The figure shows the lack of attention to general cleanliness, as the floors appear very rough, which spreads bacteria and microbes.

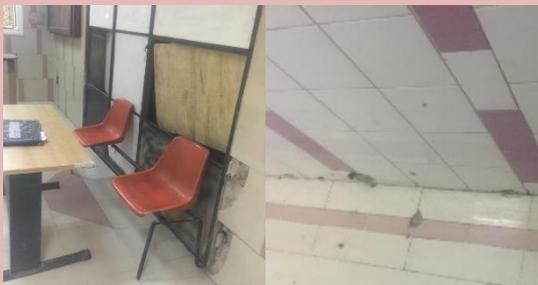
<p><u>Reception and main corridor</u> Walls: ceramic tiles The picture shows the extent of the deterioration of the ceramic tiles, as we see some tiles are eroded and have fractures, and it shows the hospital's neglect of the necessary maintenance work.</p>

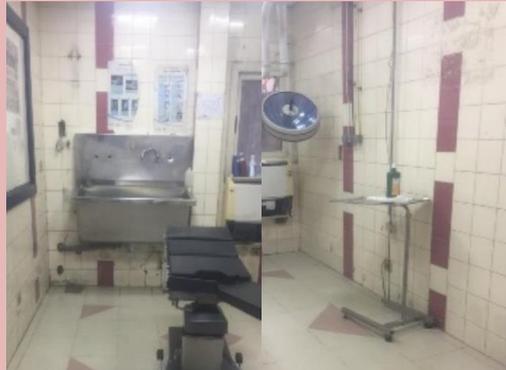
<p><u>Minimal intervention room</u> Walls: ceramic tiles The ceramic tiles under the wash basin appear poorly, as some tiles appear broken and dirt and bacteria form on them. The figure shows the hospital's lack of interest in making the necessary treatments and maintenance to prevent the formation of fungi and bacteria harmful to public health.</p>

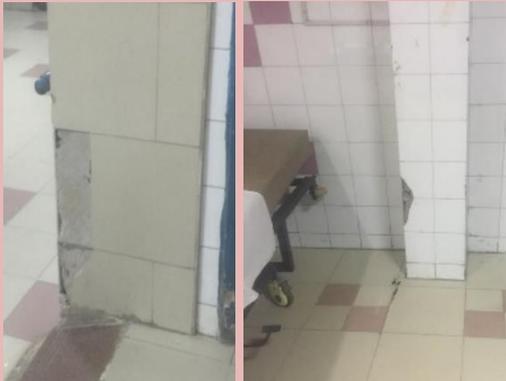
<p><u>Detection and diagnosis room</u> Walls: ceramic tiles The picture shows the appearance of deterioration and fractures in some ceramic tiles, while others do not exist, and the cement mortar appears below it, and this helps in the formation of bacteria, fungi, and the presence of insects, and this indicates the hospital's lack of attention to the maintenance and treatment factor.</p>

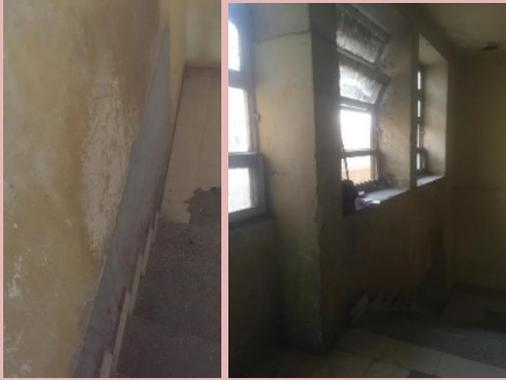
<p><u>main staircase</u> Walls: paint The picture shows the poor appearance of the paint because of moisture and because of the fingerprints of patients and users of the building. The lower parts of the wall that are exposed to moisture have been treated with cement materials, and this treatment is wrong, and its general shape is very bad.</p>

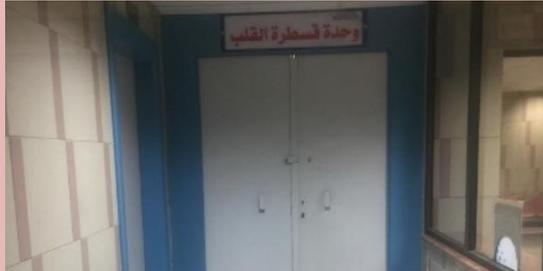
<p><u>Cardiac catheterization unit</u></p> <p>Walls: ceramic tiles</p> <p>The walls here appear in good condition and are visually acceptable, unlike most of the interior walls that will be analyzed.</p>
<p style="writing-mode: vertical-rl; transform: rotate(180deg);">First Floor</p>	<p style="writing-mode: vertical-rl; transform: rotate(180deg);">Intensive Care Unit - Ophthalmology Department</p>

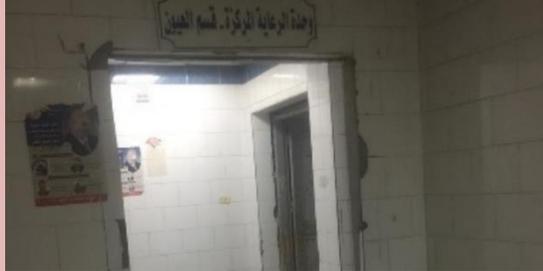
<p><u>Reception and waiting area</u></p> <p>Walls: ceramic tiles</p> <p>The figure shows the appearance of many broken and smashed ceramic tiles, especially at the edges of the entrance opening, all of which need to be replaced.</p>

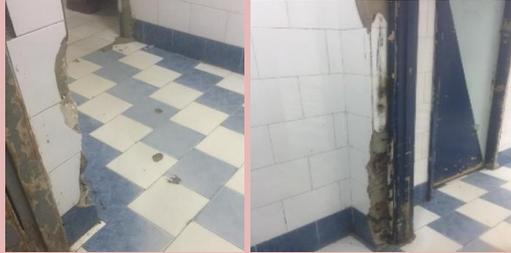
<p><u>The main corridor</u></p> <p>Walls: ceramic tiles</p> <p>The figure shows the poor appearance of the walls, where some tiles appear broken and corroded to the point that bricks appear under the cement mortar, which helps in the formation of bacteria, microbes, and the spread of insects.</p>

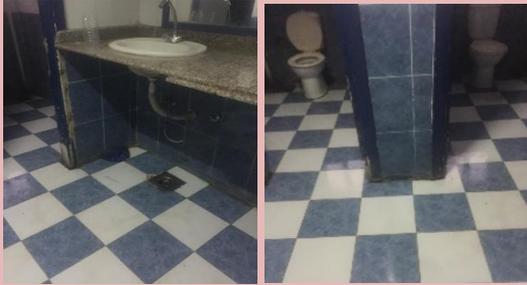
<p><u>Bathrooms</u></p> <p>Walls: ceramic tiles</p> <p>The two pictures show the lack of good insulation and neglect of general hygiene, as the walls appear in the corners and the edges of plastic, due to the use of water and the spread of moisture, which leads to the presence of bacteria and fungi and damages public health.</p>
	<p style="writing-mode: vertical-rl; transform: rotate(180deg);">Intensive Care Unit - Cardiac Department</p>

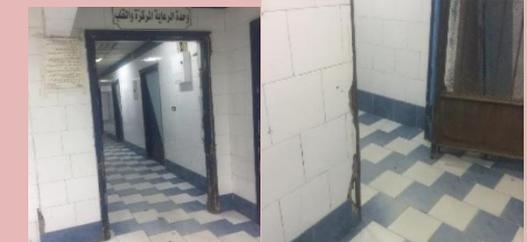
<p><u>Department entrance and waiting area</u></p> <p>Walls: ceramic tiles</p> <p>The figure shows the presence of some cracks and cracks in some ceramic tiles that were not treated by replacing them with others.</p>

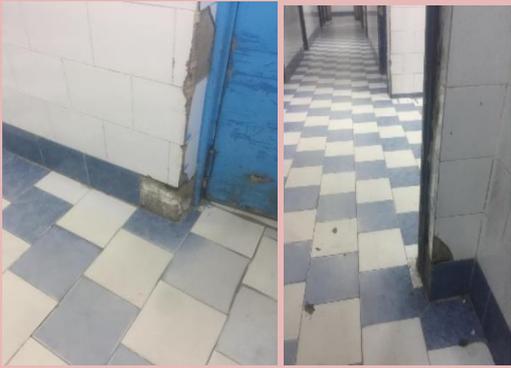
<p><u>The main corridor</u></p> <p>Walls: ceramic tiles</p> <p>The image shows the appearance of deterioration and fractures in some ceramic tiles, while others do not exist, and the cement mortar appears below it, and this helps in the formation of bacteria, fungi, and the presence of insects, and this indicates the hospital's lack of attention to the maintenance and treatment factor.</p>
<p>Second Floor</p>	<p>Vascular Surgery Department</p>

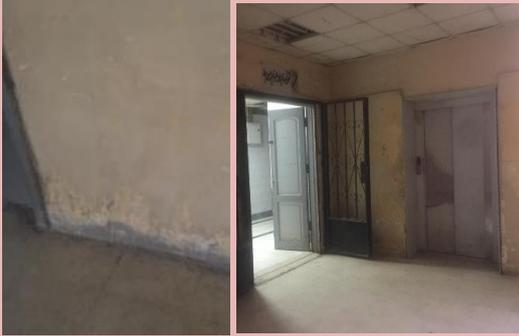
<p><u>Department entrance and waiting area</u></p> <p>Walls: paint</p> <p>The figure shows the extent to which the paint is affected by moisture and erodes, especially at the lower part of it because of washing the floors, and skirts should have been placed in this part to protect the paint from moisture as much as possible.</p>

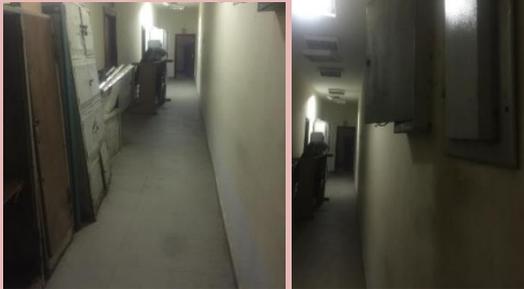
<p><u>Doctors' residence</u></p> <p>Walls: paint</p> <p>Painted walls, on which dirt is spread, appear somewhat badly because of handprints that have left dirt on them, and there is moisture under the wall, all of which works on the spread of bacteria and microbes.</p>

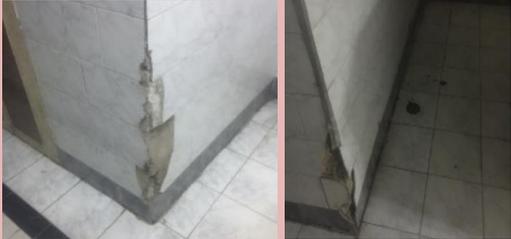
<p><u>The main corridor</u></p> <p>Walls: ceramic tiles</p> <p>The figure shows the presence of some fractures in some ceramic tiles, which makes them appear poorly, and therefore must be treated by replacing them with others.</p>

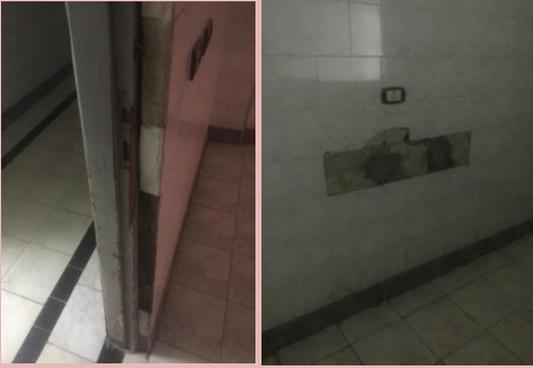
<p><u>patient care room</u></p> <p>Walls: ceramic tiles</p> <p>The image shows the appearance of deterioration and fractures in some ceramic tiles, while others do not exist, and the cement mortar appears below it, and this helps in the formation of bacteria, fungi, and the presence of insects, and this indicates the hospital's lack of attention to the maintenance and treatment factor.</p>
--	--	---	--

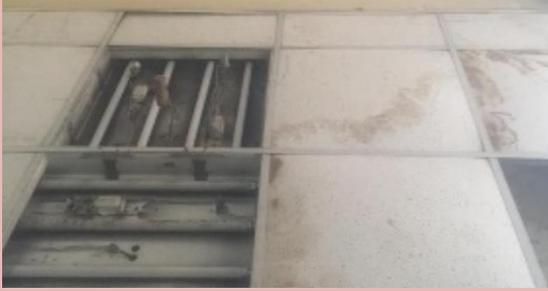
<p><u>Reception and waiting area</u></p> <p>Ceiling: suspended metal slabs</p> <p>The figure shows the hospital's lack of interest in treating or maintaining the suspended tiles, as we find that some of the tiles are not in their place as their place appears exposed, and others are either broken or moisture spreads.</p>

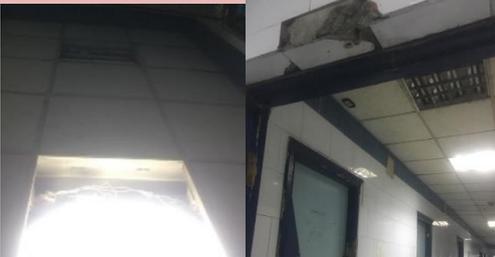
<p><u>The main corridor</u></p> <p>Ceiling: suspended metal slabs</p> <p>The figure shows the presence of spotlights without a glass cover to protect these headlights and reduce glare. It also shows the presence of some broken and smashed ceramic tiles covering the concrete beam.</p>

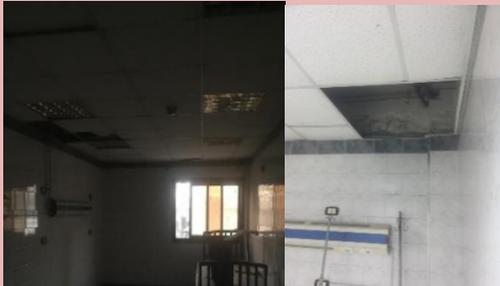
<p><u>patient care rooms</u></p> <p>Ceiling: suspended metal slabs</p> <p>The figure shows the hospital's lack of interest in treating or maintaining the suspended tiles, as we find that some tiles are not in their place, as their place appears exposed, and others are broken.</p>

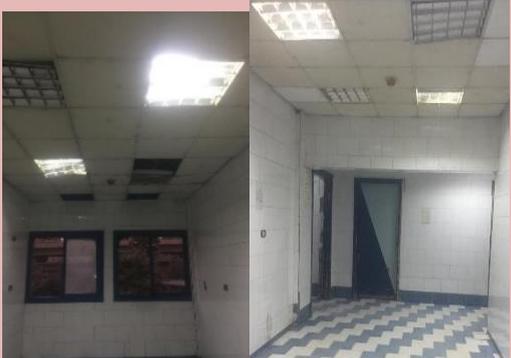
<p><u>waiting area</u> Ceiling: suspended metal slabs We note from the figure that some tiles are not located in their place as their place appears exposed, and others are broken. We also note the presence of lighting headlights without a glass cover to protect these headlights and reduce the glare of lighting.</p>

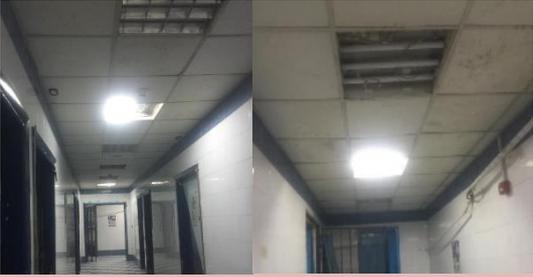
<p><u>The main corridor</u> Ceiling: suspended metal slabs The figure shows the presence of lighting headlights without a glass cover to protect these headlights and reduce glare. It also shows moisture and dirt spread on most of the tiles that need maintenance and treatment.</p>

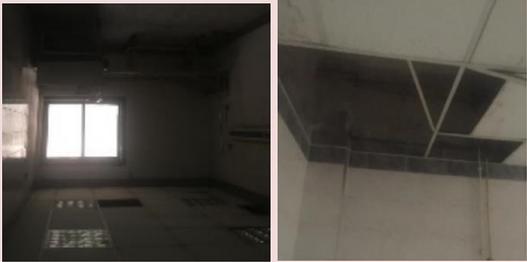
<p><u>patient care rooms</u> Ceiling: suspended metal slabs The figure shows the hospital's lack of interest in treating or maintaining the suspended tiles, as we find that some tiles are not in their place, as their place appears exposed, and others are broken.</p>

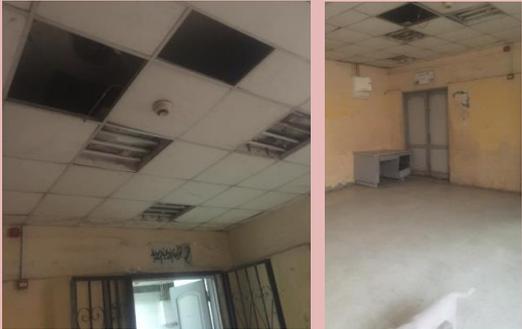
<p><u>Department entrance and waiting area</u> Ceiling: suspended metal slabs We note from the figure that some tiles are not located in their place as their place appears exposed, and we note the presence of lighting headlights without a glass cover to protect these headlights and reduce the glare of lighting.</p>

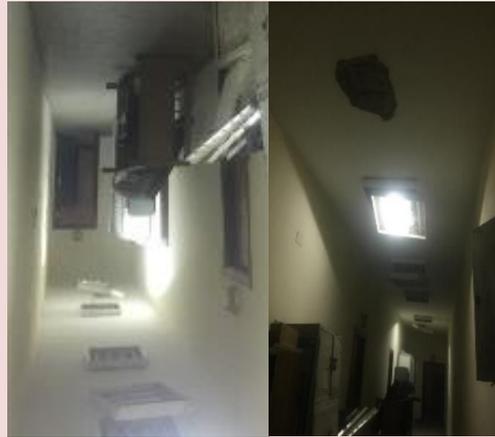
Ceiling: whiteness plaster

We notice from the figure a crack in the concrete ceiling that reaches the iron rails, and we notice that the headlights are coming out of the places where they are installed as if they will fall to the ground, and they appear without a glass cover to protect these headlights and reduce the glare of the lighting, and this indicates that the hospital does not care about the maintenance and treatment factor.

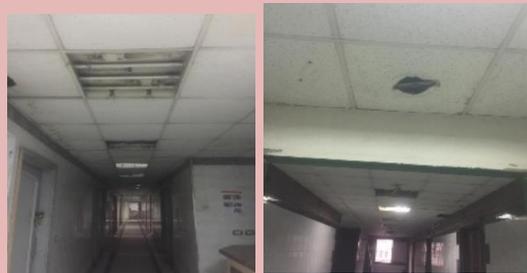
Ceiling: suspended metal slabs

The figure shows the presence of lighting headlights without a glass cover to protect these headlights and reduce glare and shows one of the tiles with a crack in the middle, and shows the moisture and dirt spread on most of the tiles that need maintenance and treatment.

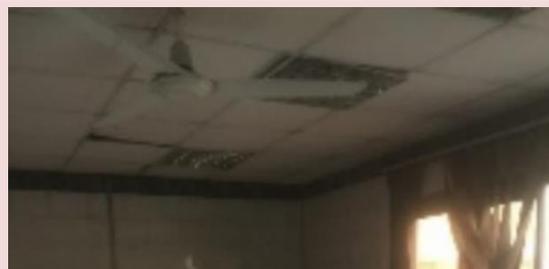
Head of Department

Ceiling: suspended metal slabs

The figure shows that the suspended tiles are not well fixed in their places, and the headlights are without a glass cover to protect these headlights and reduce glare.

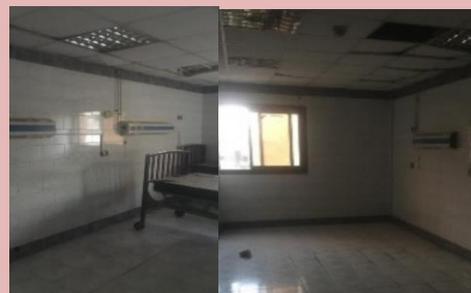
Ceiling: suspended metal slabs

We note from the figure that some tiles are not in their place, as their location appears exposed, and others are not well installed in their places. It also shows moisture and dirt spread on most tiles that need maintenance and treatment. We also note the presence of lighting fixtures without a glass cover to protect these headlights and reduce illumination glare.

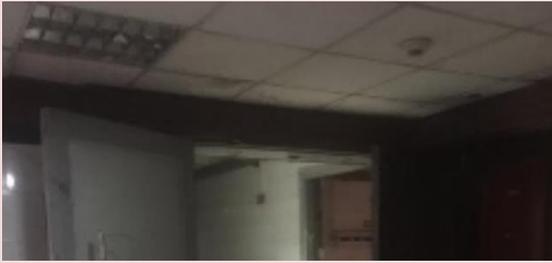
<p><u>Meeting Room</u></p> <p>Ceiling: suspended metal slabs</p> <p>We notice from the figure that some tiles spread moisture and dirt, which need maintenance and treatment. We also note the presence of a headlight without a glass cover to protect it and reduce glare.</p>

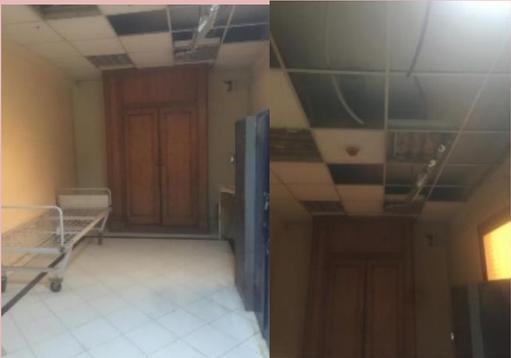
<p><u>inner corridor</u></p> <p>Ceiling: suspended metal slabs</p> <p>We notice from the figure that most of the tiles are not in their place, as their place appears exposed, and we notice that the lighting headlights come out of the places where they are installed as if they will fall to the ground, and this indicates that the hospital does not care about the maintenance and treatment factor.</p>

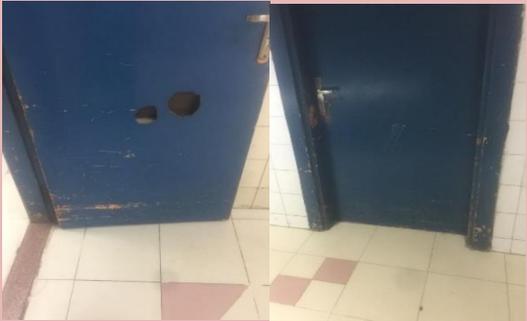
<p><u>Minor intervention room & Examination and diagnosis room</u></p> <p>The figure shows the presence of circular fractures on the surface of the door leaf, as well as the presence of erosion in the throat and door leaf that may be due to direct contact of patients' beds with it, which makes the door appear visually distorted, and exposes it to the formation of bacteria and microbes.</p>
First Floor	Intensive Care Unit - Ophthalmology Department

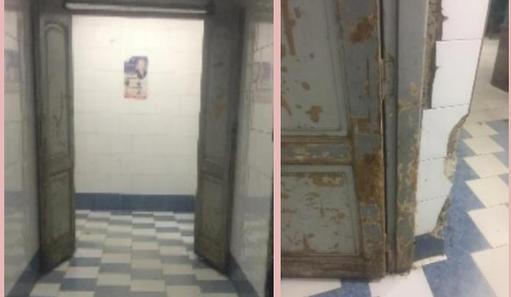
<p><u>The Main Corridor</u></p> <p>Shown here is the door of the main corridor of the department in a completely deteriorated condition, where a layer of corroded paint appears on it and wood appears under it, which may be exposed to moisture, which leads to the formation of bacteria and fungi.</p>

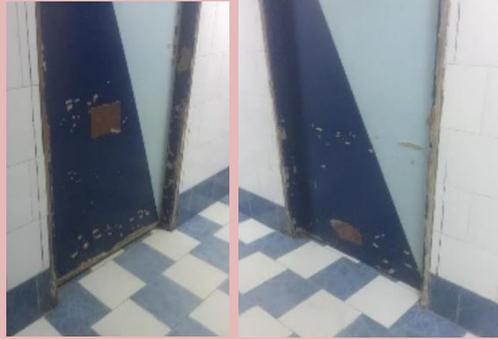
patient care rooms

The figure shows the presence of corrosion in the throat and door sill, and we note the treatment of some fractures in the doors by placing a piece of wood over the broken hole, and this is a primitive and poor treatment, which shows the door in a visually distorted way, and exposes it to bacteria and microbes.

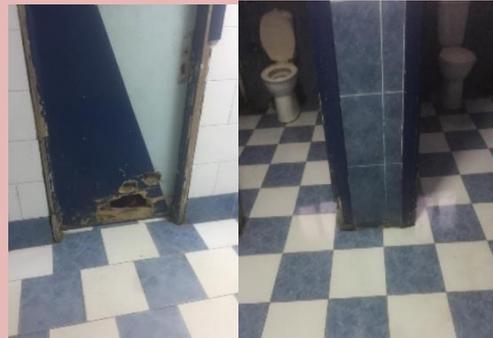
Bathrooms

The figure shows the presence of large fractures at the bottom of the door, as well as the presence of corrosion in the throat and door leaf and shows the spread of moisture in the lower parts of the interior doors because of the spread of moisture, which in nature works to rot wood and the spread of bacteria and fungi.

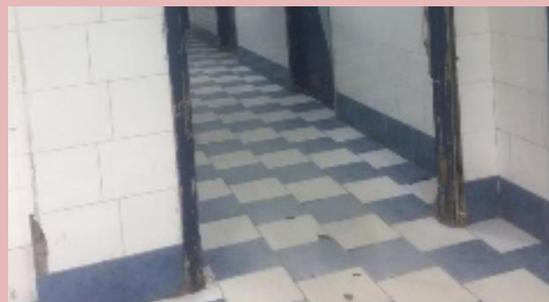
Department entrance

The figure shows the deterioration of the condition of the door of the main corridor of the department, where a layer of paint appears corroded and wood appears beneath it, the lower part of which has been exposed to moisture, which leads to the formation of bacteria and fungi.

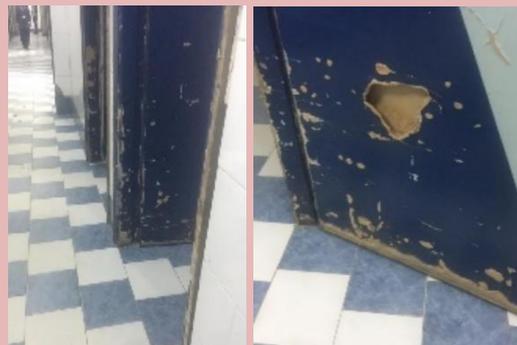
patient care rooms

The figure shows the presence of fractures in the lower part of the door, as well as the presence of erosion in the throat and door leaf, which may be due to direct contact of patients' beds with it, which makes the door appear in a visually distorted form, exposing it to the formation of bacteria and microbes.

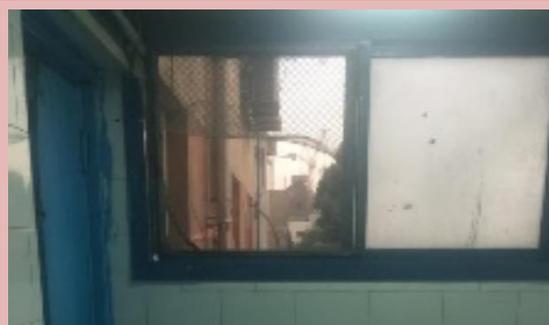
waiting area

The window here appears very badly, as we notice that the wire layer that protects the vacuum from entering insects is corroded, and it needs maintenance by replacing it with a new piece.

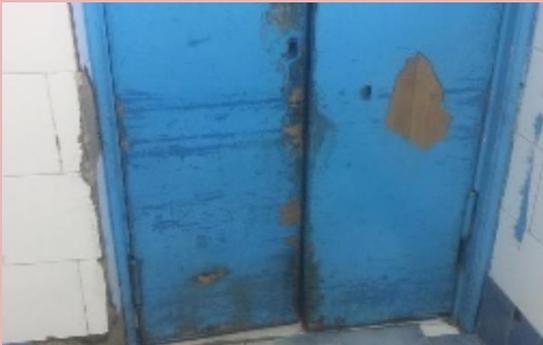
<p style="text-align: center;"><u>Store</u></p> <p>The figure shows the presence of major fractures and scratches in the door and shows the presence of corrosion in the throat and door leaf, which shows the door in a visually distorted way, which shows the severe neglect of the hospital in the work of maintenance and the necessary treatments.</p>
<p style="text-align: center;">Second Floor</p>	<p style="text-align: center;">Vascular Surgery Department</p>

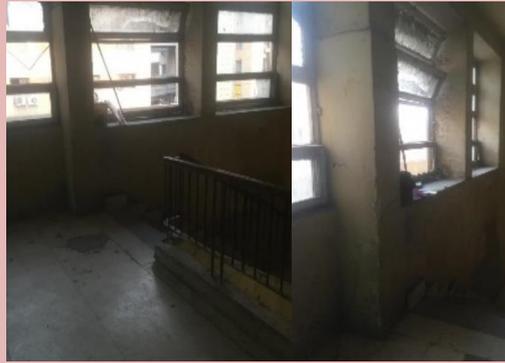
<p style="text-align: center;"><u>Main Staircase</u></p> <p>The ventilation and lighting windows of the main staircase appear very badly, as dust and dirt resulting from weather factors accumulate on the surfaces of the glass, which does not contain any treatment technology, unlike the absence of some glass sashes from the foundation, and moisture spreads on the walls around it.</p>

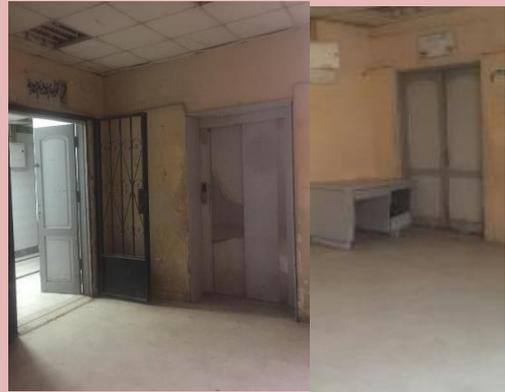
<p style="text-align: center;"><u>Department entrance and waiting area</u></p> <p>The figure shows the deterioration of the elevator door that has been treated incorrectly. It also shows the erosion of the paint layer and the presence of many scratches on the bottom of both the main door of the entrance to the department and the main door of the urology department, which led to the formation of bacteria because of moisture.</p>

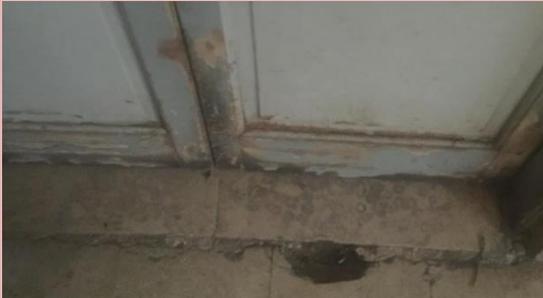
<p style="text-align: center;"><u>Doctors' residence</u></p> <p>The figure shows the deterioration of the condition of the main door of the doctors' residence, especially the lower part of it, where a layer of corroded paint appears and wood is exposed under it, which has been exposed to moisture, which leads to the formation of bacteria and fungi.</p>

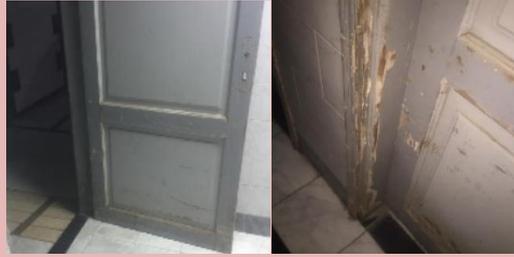
Some patient care rooms

The figure shows the presence of erosion in the throat and door leaf, which may be due to direct contact of patients' beds with it, which makes the door appear visually distorted, and exposes it to the formation of bacteria and microbes.

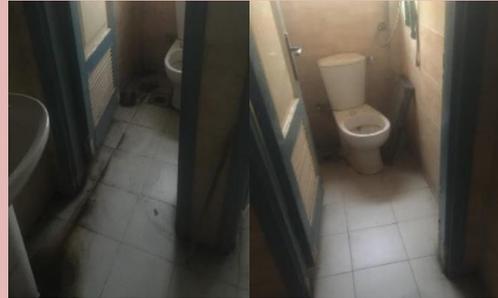
Bathrooms

The figure shows the erosion of the paint layer in the lower parts of the doors because of water, which led to the appearance of wood, which rotted due to its constant exposure to moisture, which led to the formation of bacteria and fungi inside these doors.

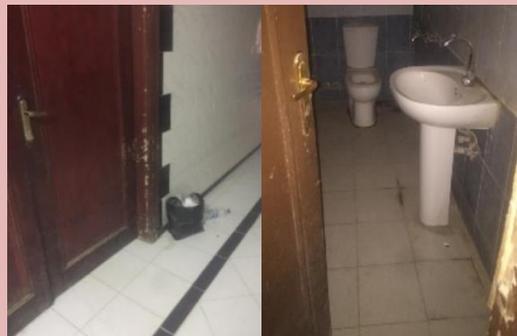
The general manager and his bathroom

The figure shows the presence of corrosion in the door throat and some scratches in the door leaf, which makes the door appear visually distorted, and exposes it to the formation of bacteria and microbes because of the spread of moisture, especially in the bathroom door.

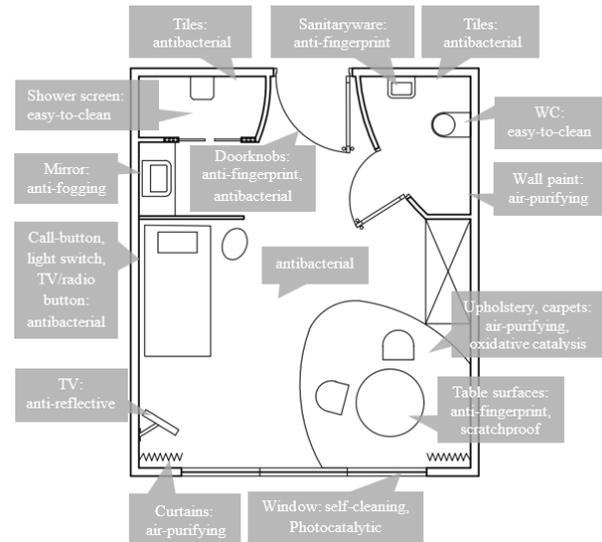
Figure (31) shows a horizontal plan of a patient room in a hospital showing the techniques and nanomaterials used in each element of the room.⁵

Technical	Design Element	Result
Self-cleaning (Photocatalysis)	the window	<ul style="list-style-type: none"> - Reduce dirt - Reducing the consumption of raw materials - Reducing maintenance costs - Improving visibility and increasing the purity of the light entering the interior space - Reducing the costs of energy consumption used in lighting - Reducing the energy consumed in air conditioning works by 10%-20%
	walls	<ul style="list-style-type: none"> - Improving air quality
