Rehabilitation of RC deep beams failing in shear using CFRP sheets and steel plates.

1 Department of Civil Engineering, College of Engineering, University of Basrah, Basrah, Iraq

Abstract

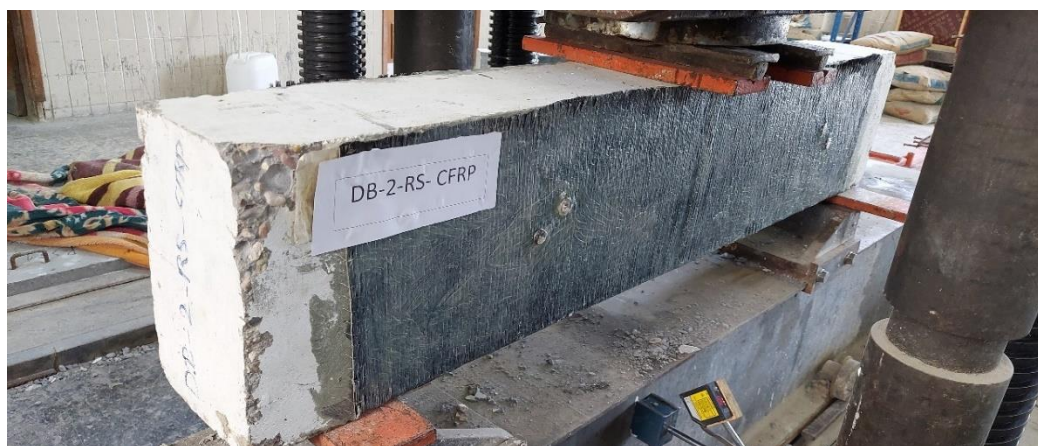
Fig.5 Simply supported reinforced deep-beam under two axial load,

3. Test Setup : The beam-specimens were tested over a simply supported span of 700, 950, 1200mm, as illustrated in Fig.(5). Two point loads were applied; the distance between two point loads was 200mm. The beam test was started by the application 100kN load to set and check the dial gages then unloading to zero. At zero loading, the initial reading of the dial gage. Then, the load was increased gradually in steps, while the strain, and deflection measurements were recorded simultaneously until failure occurs. A magnifying glass was used to detect the cracks at each load. Cracks were detected and drawn on the face of the tested beam.

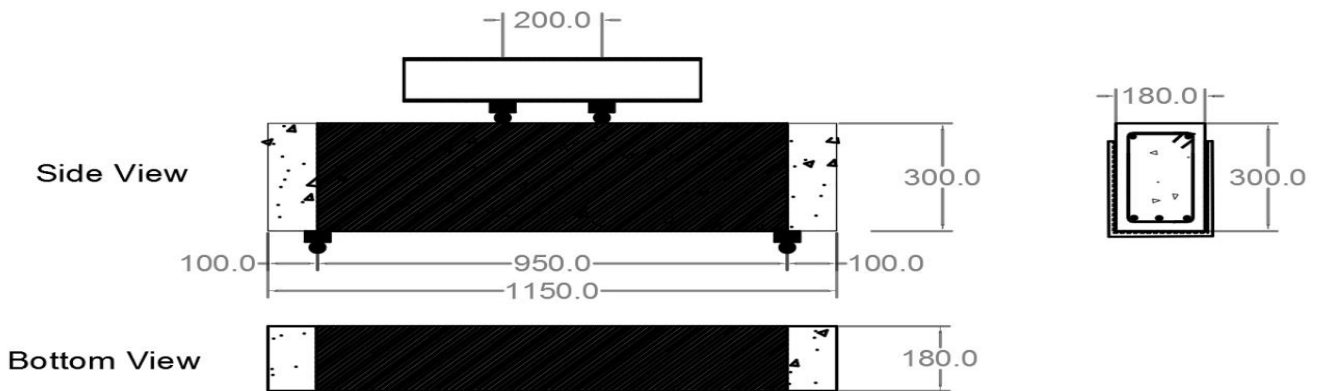
Figure (6): Details of external CFRP sheets for repaired beams in Shear.

The exterior steel plate was bonded to repair beams have depth (250 mm) on two side only constant thickness. As illustrated in fig(6)and fig(7)

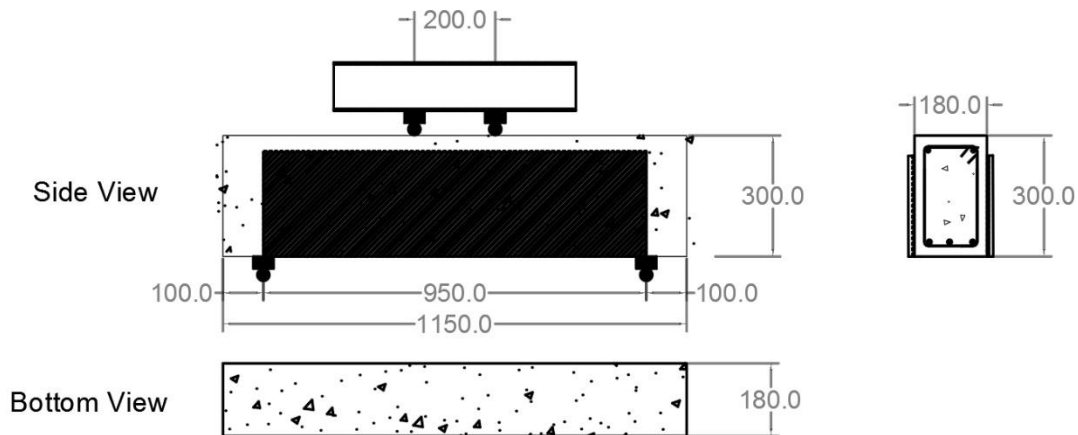
Figure (7): Details of external Steel Plates for repaired beams in Shear.

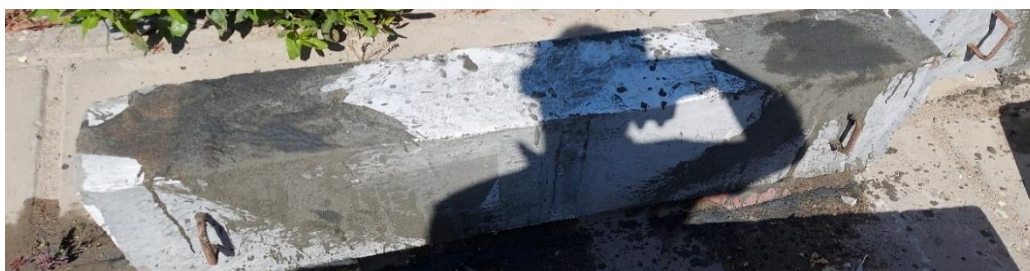
Fig (8). Repaired beams with cementitious grout

- The first step in repairing restore the original shape of the specimen. A reverse load is applied to the beam until it straightens out again, or almost so.
- Crushed concrete in the failure zone is chipped out in both tension and compression zones. Then, it is replaced by cementitious grout with higher properties than old concrete, as shown in Fig (8).

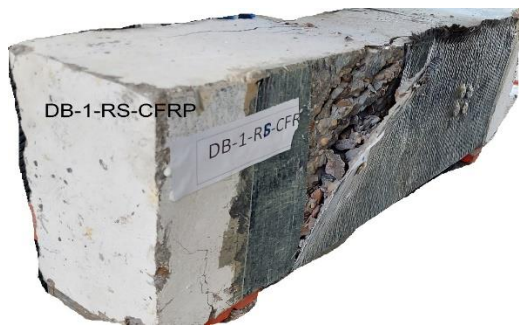
Figure (10): Failure mode for Rehabilitated Deep Beam with (a/d=1) failed in shear - DB-1-RS-CFRP

Beam (DB-1-RS-CFRP) fails by reopening healed cracks and debonding of sheet from one end that began under the crack zone. The use of epoxy glue is insufficient to achieve composite action between concrete and steel, and so cannot avoid debonding failure. This beam has a restored efficiency (96.1 percent).

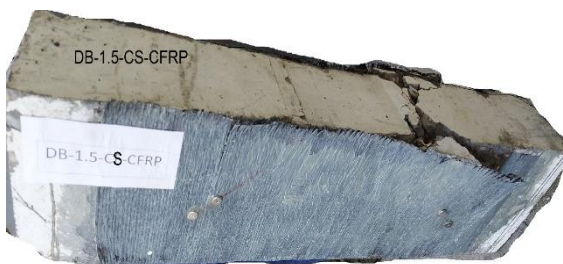
Figure (11): Failure mode for Rehabilitation Deep Beam with (a/d=1.5) failed in shear - DB-1.5-CS-CFRP

The control deep beams (DB-1-CS-CFRP, DB-1.5-CS-CFRP, and DB-2-CS-CFRP) did not show any increase in ultimate load since they fail before reaching their original capacity owing to complete beam damage. The beam (DB-2-RS-CFRP) achieves the best ultimate load result by with shear strength efficiency (154.4 percent). This beam collapse was due a new flexural shear crack in the opposite span, distant from the repaired cracks, creating substantial local interfacial stresses between the CFRP sheets layer and the concrete at the crack zone. This causes debonding or crushing of sheets beginning in this zone.

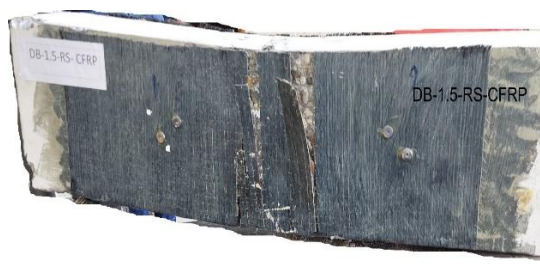
Figure (12): Failure mode for Rehabilitated Deep Beam with (a/d=1.5) failed in shear - DB-1.5-RS-CFRP

Beam (DB-1.5-RS-CFRP) has repaired efficiency (105.1%), and the beam failed due to the reopening of a previously repaired major shear crack that spreads across the width of the beams to the opposite face and a new failure mode develops in the flexural zone, resulting in the beam's final failure, with tearing off of the concrete cover and separation of CFRP sheets at this zone.

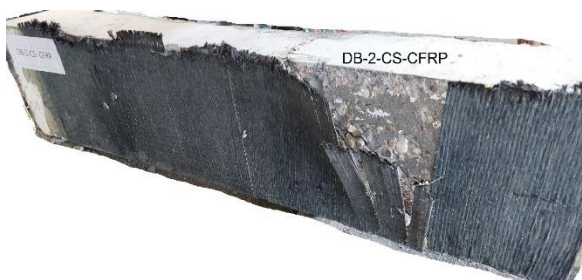
Figure (13): Failure mode for Rehabilitated Deep Beam with (a/d=2) failed in shear - DB-2-CS-CFRP

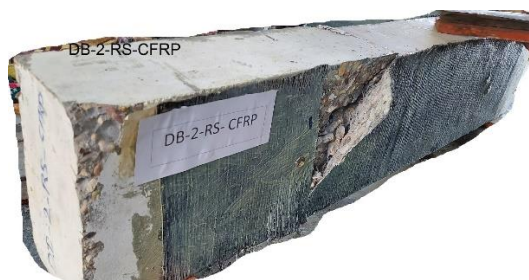
Figure (14): Failure mode for Rehabilitated Deep Beam with (a/d=2) failed in shear - DB-2-RS-CFRP

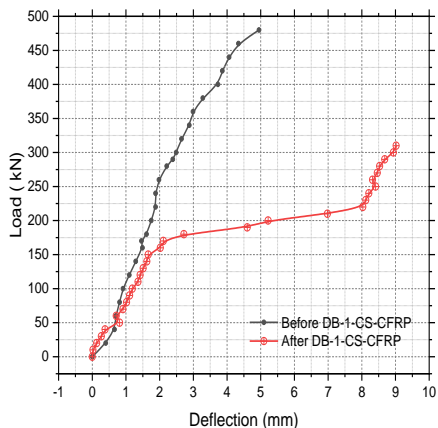
Fig.(15):Load-Deflection curve for beam(DB-1-CS-CFRP).

the comparison of load vs. mid-span deflection for control, original (loaded to 0.8 Pu) and repaired beams. It can be noticed that for beams loaded to failure then repaired with CFRP (DB-1-CS-CFRP, DB-1.5-CS-CFRP and DB-2-CS-CFRP), the deflections of the repaired beams (at 60% of ultimate load) are greater than their original beams by (361.3, 329.6 ,133.1 %) respectively.

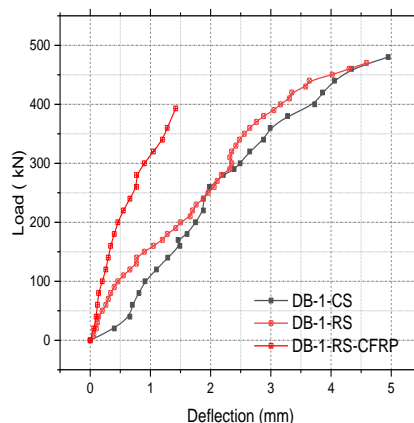
Fig.(16):Load-Deflection curve for beam(DB-1-RS-CFRP).

The deflection of repaired beam (DB-1-RS-CFRP) is lower than that of the original beam with ratio 87.0 %, and beam (DB-1.5-RS-CFRP) recorded ratio (108.2%) therefore, its showed lower stiffness.

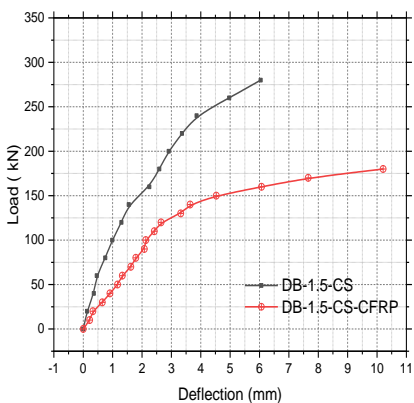
Fig.(17):Load-Deflection curve for beam(DB-1.5-CS-CFRP).

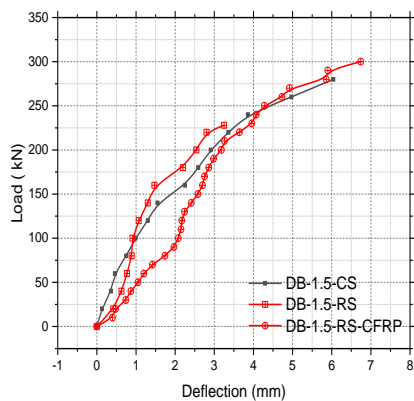
Fig.(18):Load-Deflection curve for beam(DB-1.5-RS-CFRP).

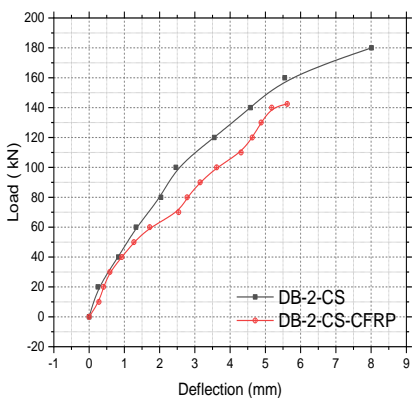
Fig.(19):Load-Deflection curve for beam(DB-2-RS-CFRP).

The best deflection is achieved in beam (DB-2-RS-CFRP), the repaired beam showed, at service load (which is 70% of ultimate load), (69.4 %) lower deflection compared to control beam deflection, which means a significant increase in stiffness which was provided by CFRP.

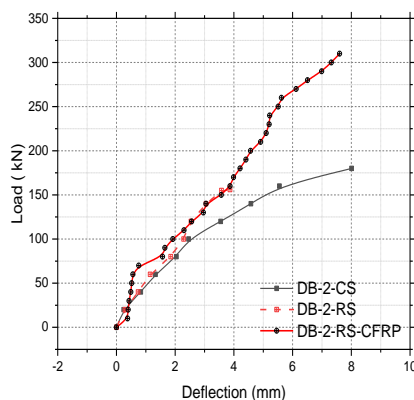
Fig.(20):Load-Deflection curve for beam(DB-2-RS-CFRP).

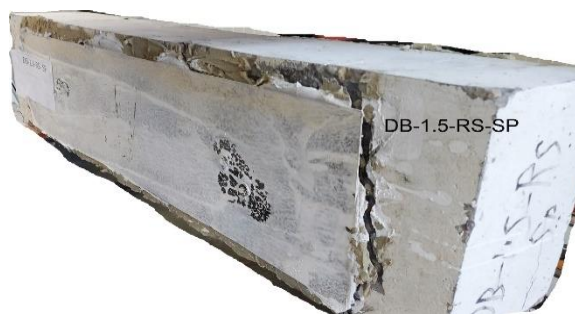
Figure (22): Failure mode for Rehabilitated Deep Beam with ($a/d=1.5$) fail in shear - DB-1.5-RS-SP

Beam (DB-1.5-RS-SP) has repaired efficiency 141.1 percent. Reopening of a previously repaired major shear crack caused the concrete cover to tear off and the steel plate zone to separate in this beam, which led directly to its failure.

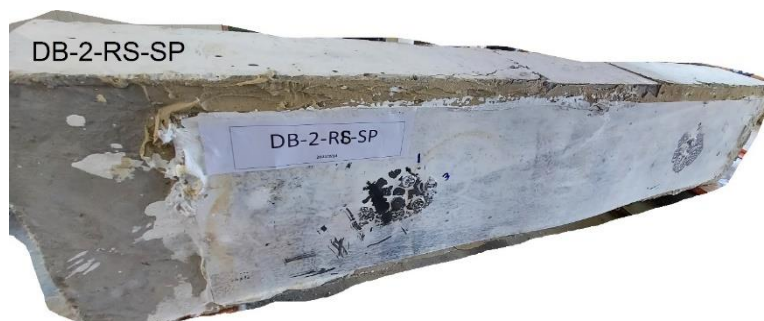
Figure (23): Failure mode for Rehabilitation Deep Beam with ($a/d=2$) fail in shear - DB-2-RS-SP

The beam (DB-2-RS-SP) achieves the best ultimate load result by recording repairing shear strength efficiency (179.5 percent). This beam collapses as a result of a new flexural shear crack that extends towards the point of applied loads, creating substantial local interfacial stresses between the steel plate layer and the concrete at the crack zone. This causes plate debonding to begin in this zone.

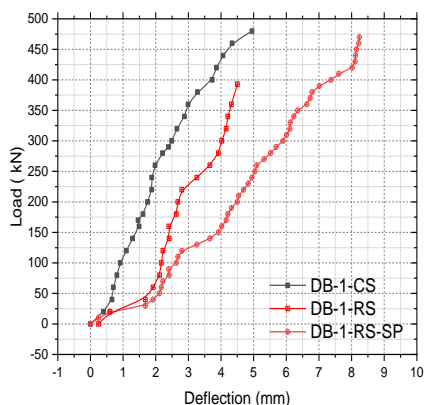
Fig.(24):Load-Deflection curve for beam(DB-1-RS-SP) compare with deflection of control beam.

Figure (24) shows the deflection of beam (DB-1-RS-SP) which is (217.4%) higher than that of the control beam at service load, which can be related to the difference in stiffness between the integrated (original) beam and the bonded (repaired) beam, as well as the presence of hair line cracks in the repaired beam.

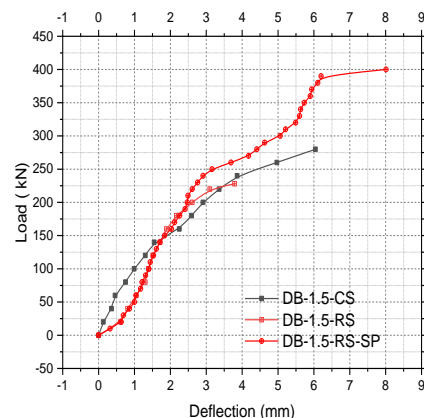
Fig.(25):Load-Deflection curve for beam(DB-1.5-RS-SP) with compare with deflection of control beam.

Fig (25 and 26) illustrates that, for beams (DB-2-RS-SP and DB-1.5-RS-SP), the deflections, at service load, of the repaired beams are smaller than those of the control beam's with ratios of (94.6, 84.4 %) respectively.

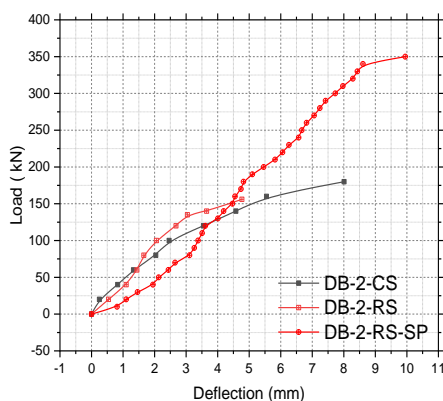
Fig.(26):Load-Deflection curve for beam(DB-2-RS-SP) compare with deflection of control beam.
