Failure Detection of Different Composite Pressure Vessels

Abstract. Pressure vessel can be dangerous if they are not properly maintained since they hold materials at high temperature or high pressure. Maintenance process of pressure vessels is an important aspect since it help to reveal the potential problems before they further developed. In present paper, two of the most used failure detection techniques are applied, the extensive experimental ultrasonic wave velocity US and X-ray CT on 75% wt. KF/epoxy laminates and 75% wt. GF/epoxylaminates with four different fiber orientations namely $[\pm 45^\circ_3]$, $[\pm 55^\circ_3]$, $[\pm 65^\circ_3]$ and $[\pm 75^\circ_3]$ are exposed to internal pressure load to compare the behavior of composite laminates and to detect the formed defects. The capability of ultrasonic wave testing and X-ray CT to obtain general information about the internal structure and to detect the defects was investigated. The internal pressure test show the superiority of $[\pm 45^\circ_3]$ and $[\pm 55^\circ_3]$ to resist internal pressure for both composite laminates. The ultrasonic wave velocity show simple fluctuating in wave velocity was for GF/epoxy lamin

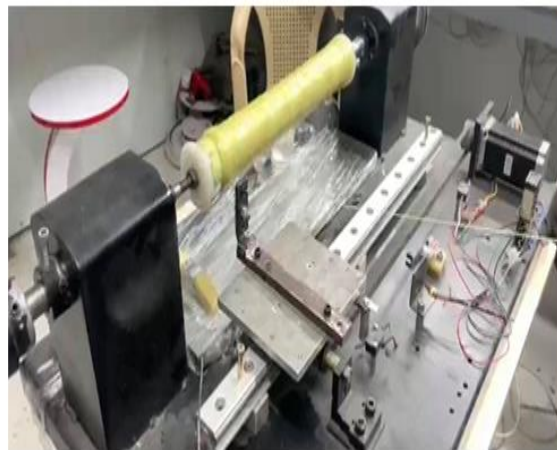
Materials and Preparation.The E-glass fiber Roving continuous product of Hebei Yuniu Fiberglass manufacturing Co., Ltd, and Kevlar fiber from Hitex® insulation & composites are mixed with Sikadur-52 LP (IN) Epoxy resin and Hardener (80:20). The Prepared resin was deposited into the resin bath tank. The process at desired parameters was began by loading the motion codes to filament wound machine shown in Fig. 1.

Fig. 1: The filament wound machine construction and elements.

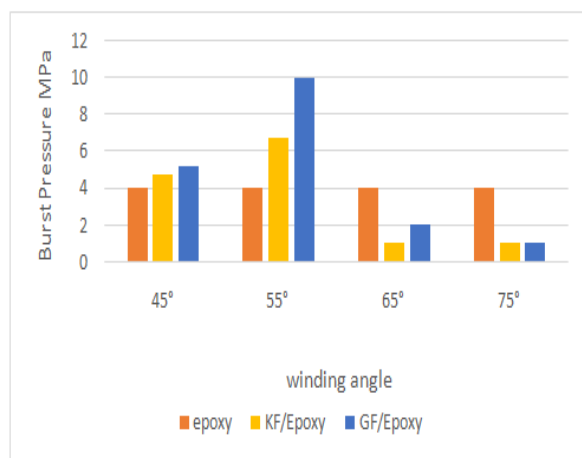
Internal pressure behavior. In order to determine the composite laminates behavior KF/epoxy laminates and GF/epoxy laminates with different orientation are subjected to 100 bar of internal pressure load. The result of internal pressure behavior of epoxy tube, KF/epoxy laminate and GF/epoxy laminate are shown in Fig 4.

Fig.4: Internal pressure behavior of KF/epoxy laminates and GF/epoxy laminates.

Examining Fig. 4, it can be seen that the epoxy tube burst strength enhanced with reinforcing with fibers with $[\pm 45^{\circ}_3]$ and $[\pm 55^{\circ}_3]$ winding orientation. The epoxy tube exhibited a brittle fracture due to internal pressure load at 4 Mpa. as shown in Fig. 5. the burst pressure higher for winding angles $[\pm 45^{\circ}_3]$ and $[\pm 55^{\circ}_3]$ while for larger winding angle the burst pressure decrease for $[\pm 65^{\circ}_3]$ and $[\pm 75^{\circ}_3]$ for the both type of fiber composite laminates. However, the epoxy tube show higher pressure than $[\pm 65^{\circ}_3]$ and $[\pm 75^{\circ}_3]$ since epoxy tube has large thickness higher than all composite laminate. The failure mechanism appears as water leakage as shown in Fig. 6.

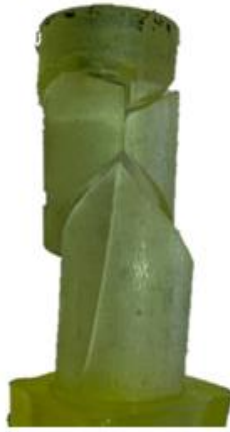
Fig. 5: Epoxy tube failure after burst pressure test.

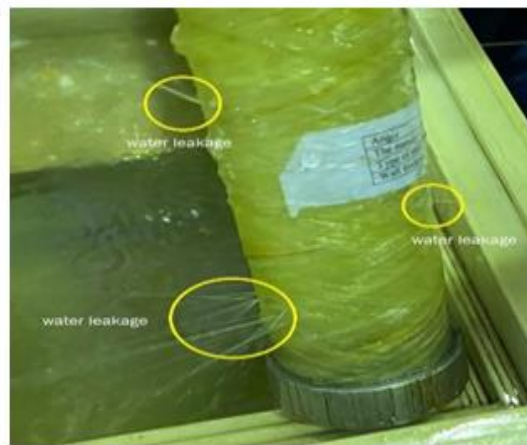
Fig. 6: the water leakage results from burst pressure test.
